Case Study
30 MW rotor repair

Status report

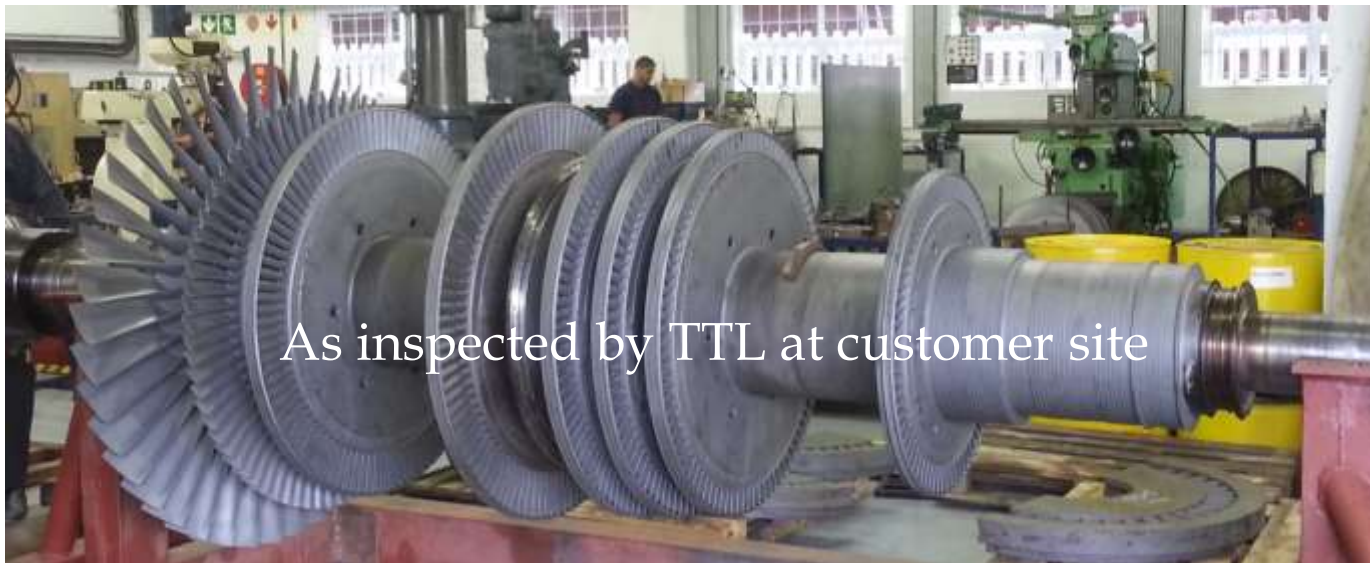
- After start up in the process of opening extraction a transient surge took place and the plant tripped.
- On opening, major damage to the rotor, found damaged and one blade in row 5 broken.
- Consulted number of companies none of whom were able to give a concrete recommendation

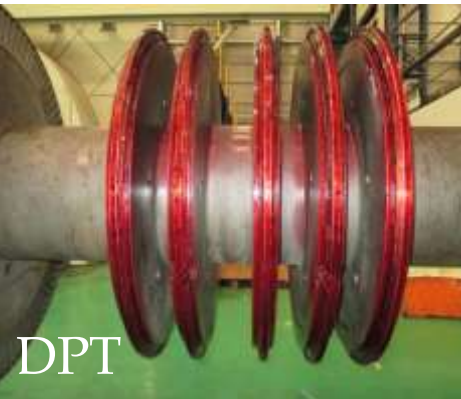
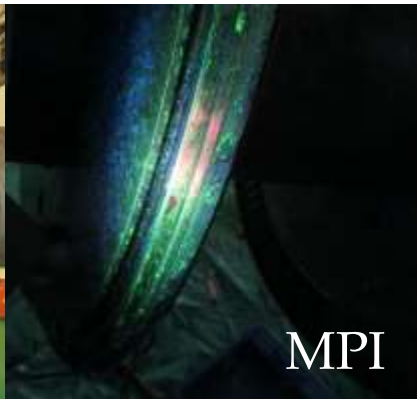
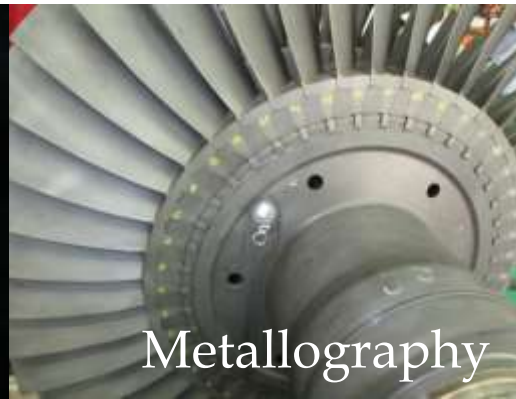
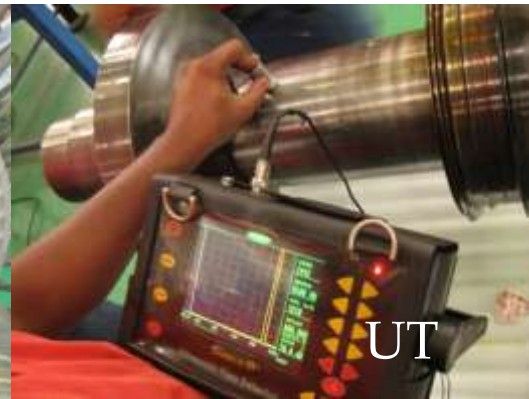
Tests carried out to establish integrity and life of rotor

- RLA,NDT,MPI,DPT
- De-blading
- Shot peening
- Surface inspection
- Reverse engineering
- Blading
- Blade locking
- High speed balancing

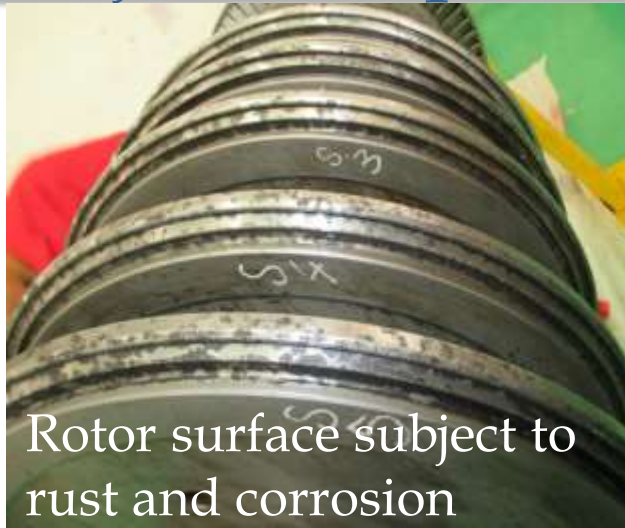
Rotor surface subject to rust and corrosion

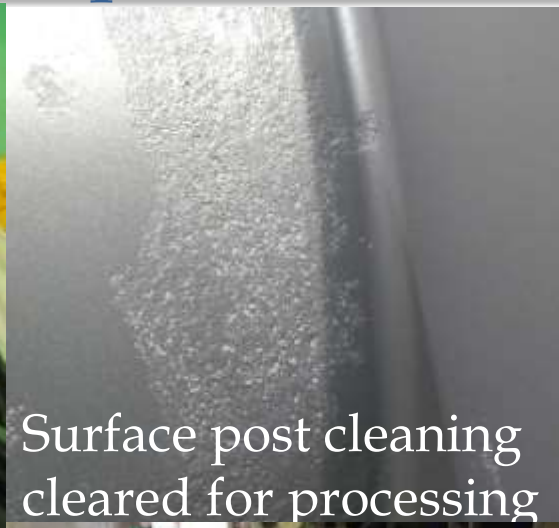
Surface post cleaning cleared for processing

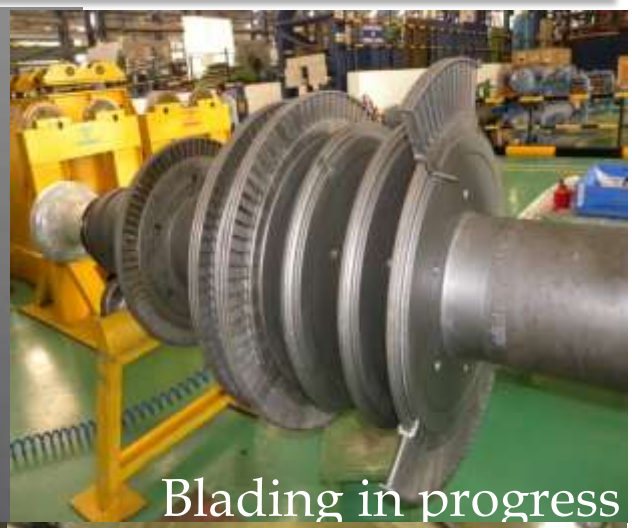
Blading in progress

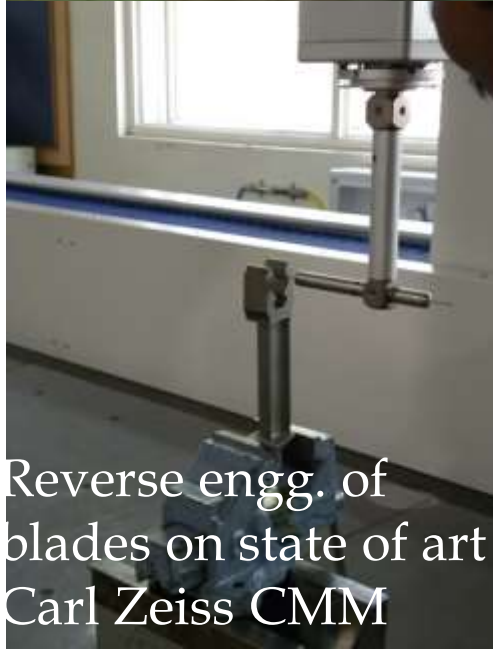
Reverse engg. of blades on state of art Carl Zeiss CMM

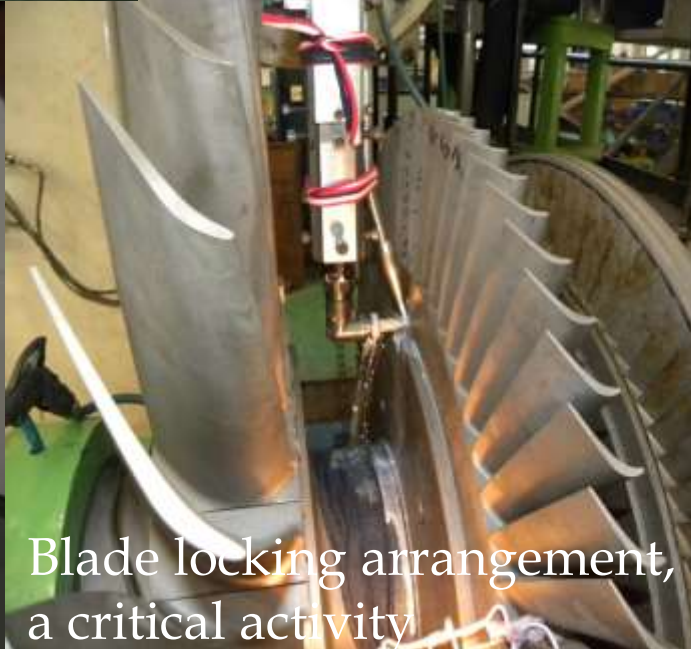
Blade locking arrangement, a critical activity

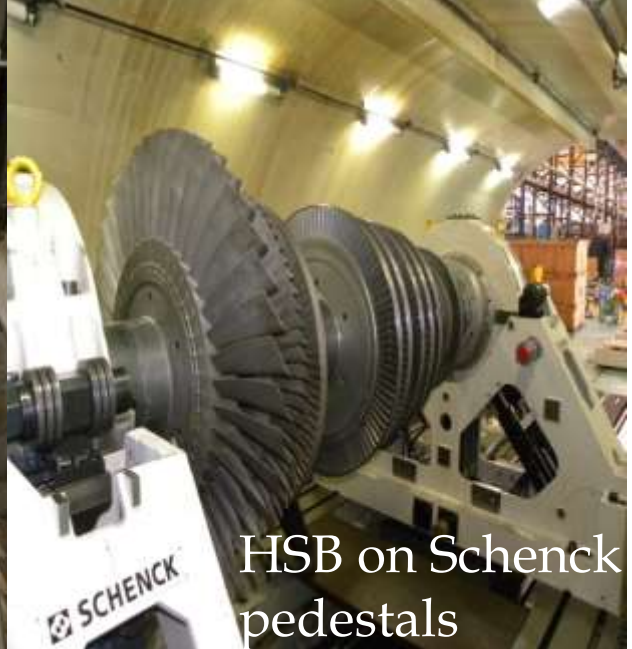
HSB on Schenck pedestals

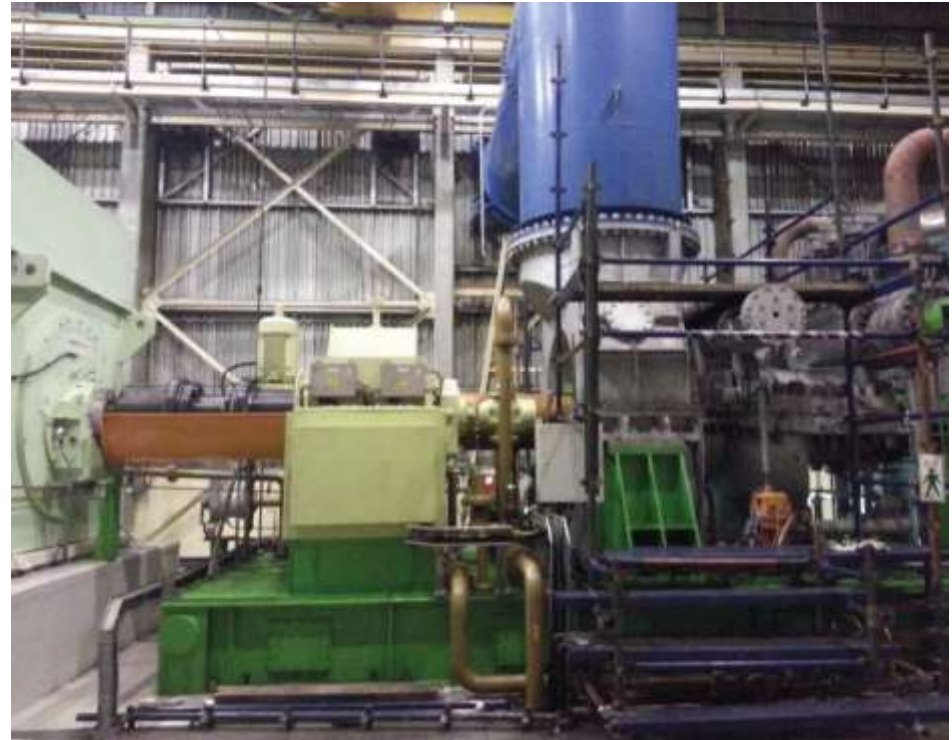
Plant after start up and synchronization
