Case Study

Repair & Efficiency improvement of turbine

Status report

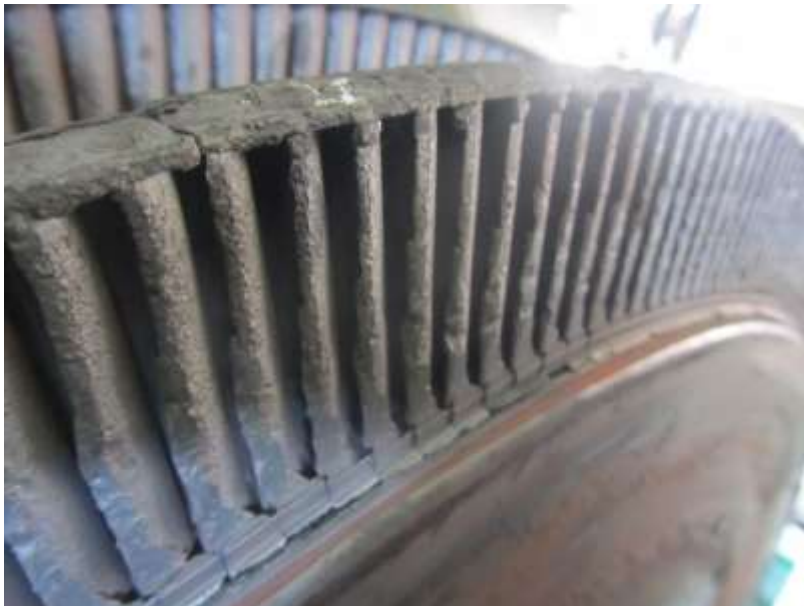
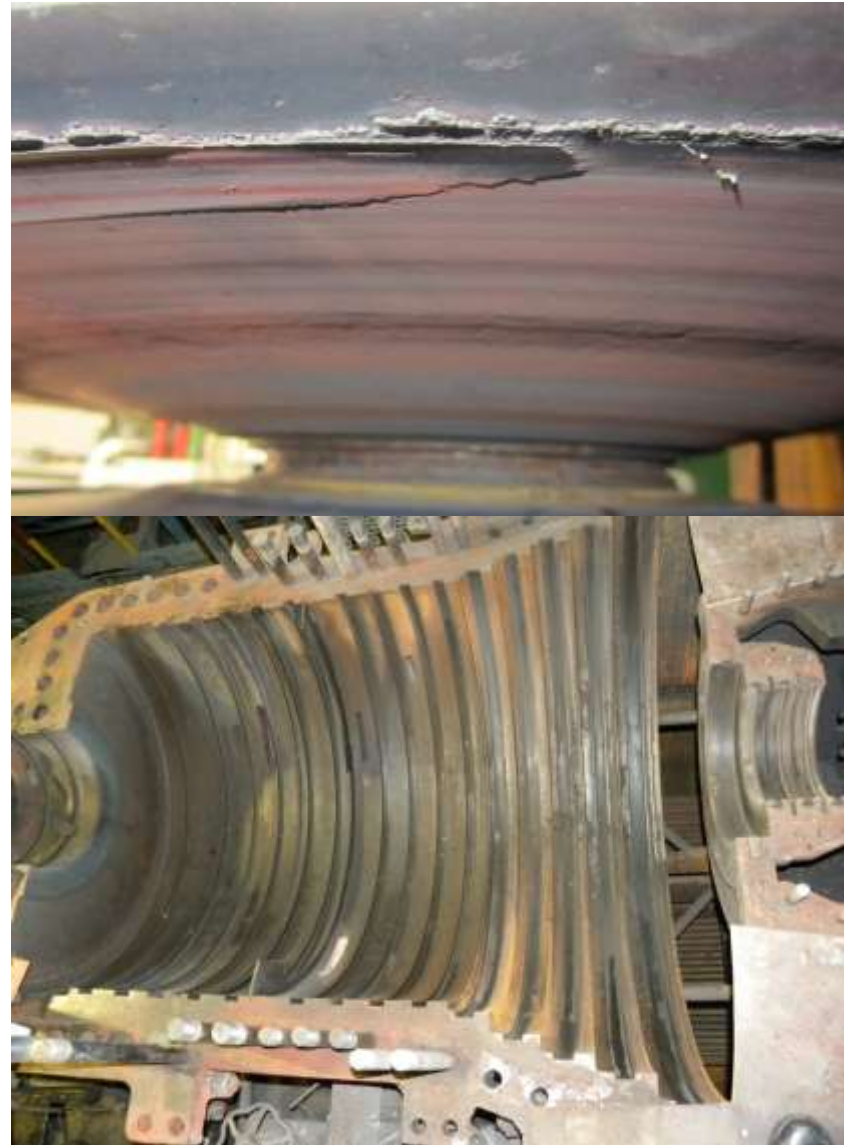
- Turbine tripped and reached over speed
- Turbine shut down and opened the same.
- Damage to the rotor and diaphragms.

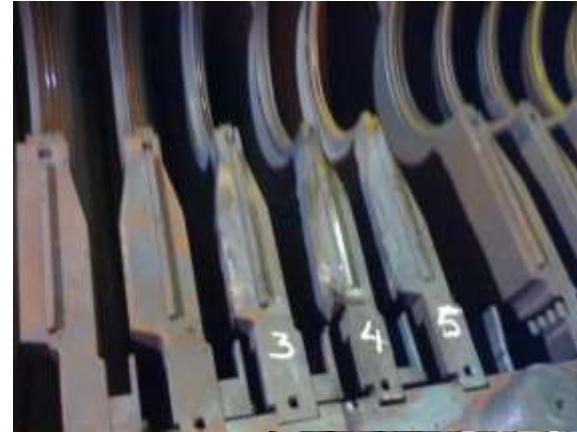
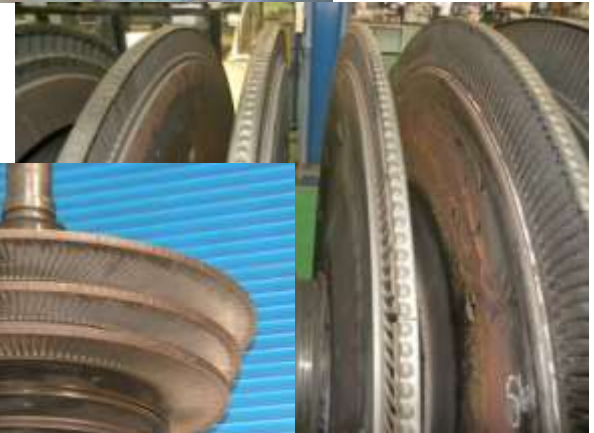
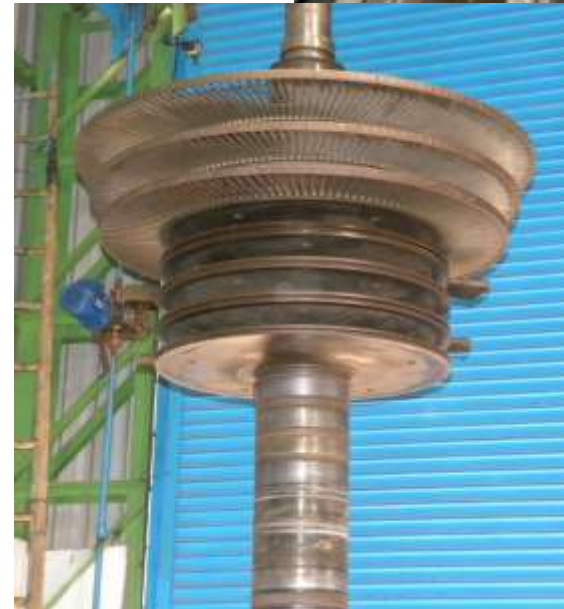
- On inspection found all parts rubbed and fused due to high temperature
- Triveni immediately deputed engineers to establish possible causes for failure and also make a techno commercial offer
- Offer submitted and due diligence done by the customer before placing order in Triveni

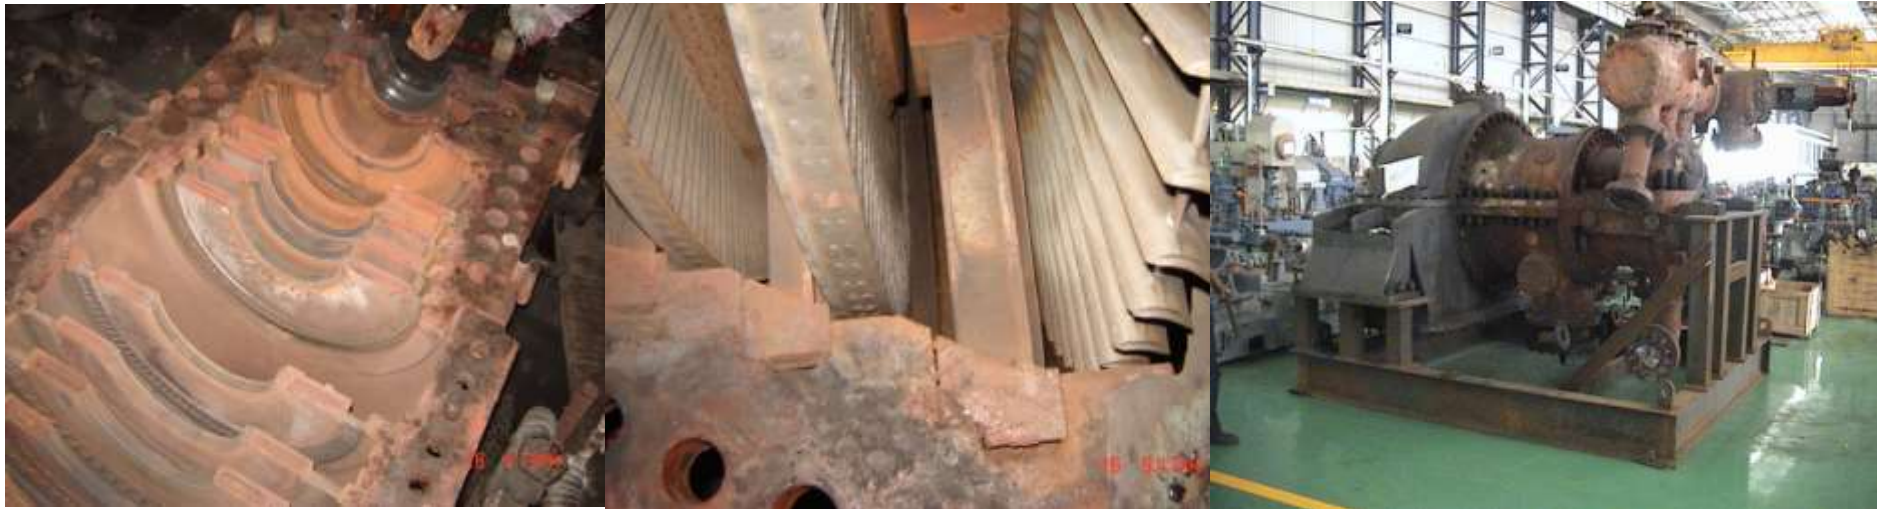
As received turbine and view of internals
