Case Study
30 MW rotor bend removal and repair

30 Mw turbine rotor repair

30 MW SIEMENS HP ROTOR REPAIR A/C UGAR SUGARS (R-0745)

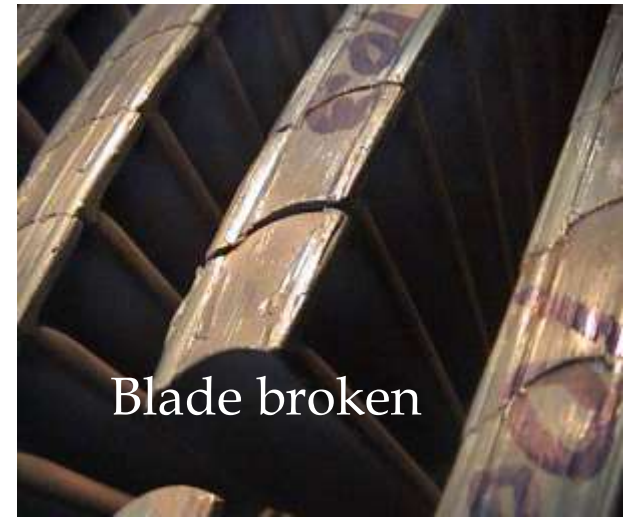
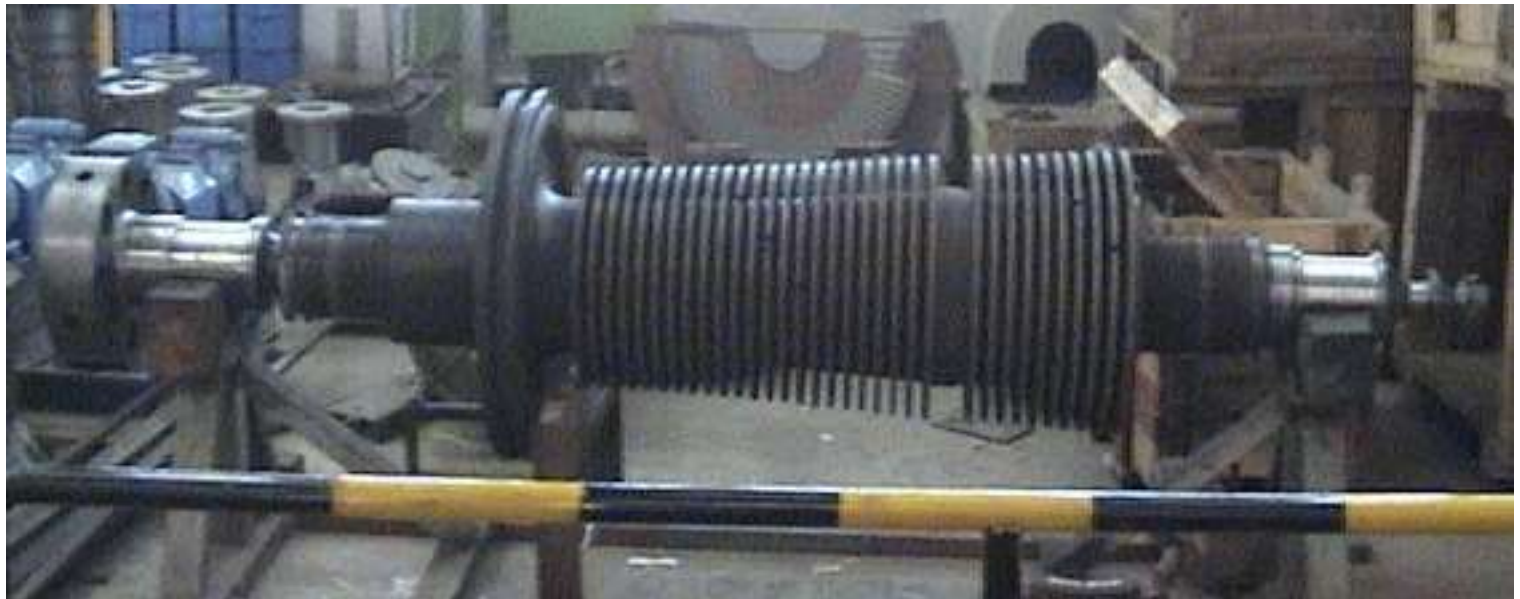
Status check at Works

- Rotor removed and transported to Bangalore works and a run out check done
- Rotor Gland areas subjected to heavy rubbing & rotor seized *due to complex bend of 1.8 mm and blade breakages*
