Case Study  
10 MW Turbine rebuild

# Status report

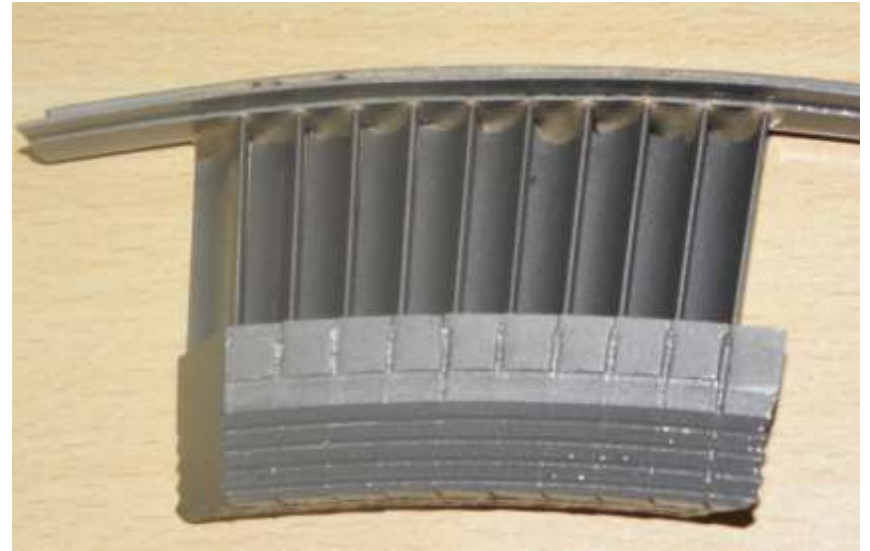
- The blades in the rotor and GBC were in packets and brazed with gold and silver
- Complete reblading of rotor and GBC was required besides other improvements
