Case Study
60 MW rotor repair

Status report

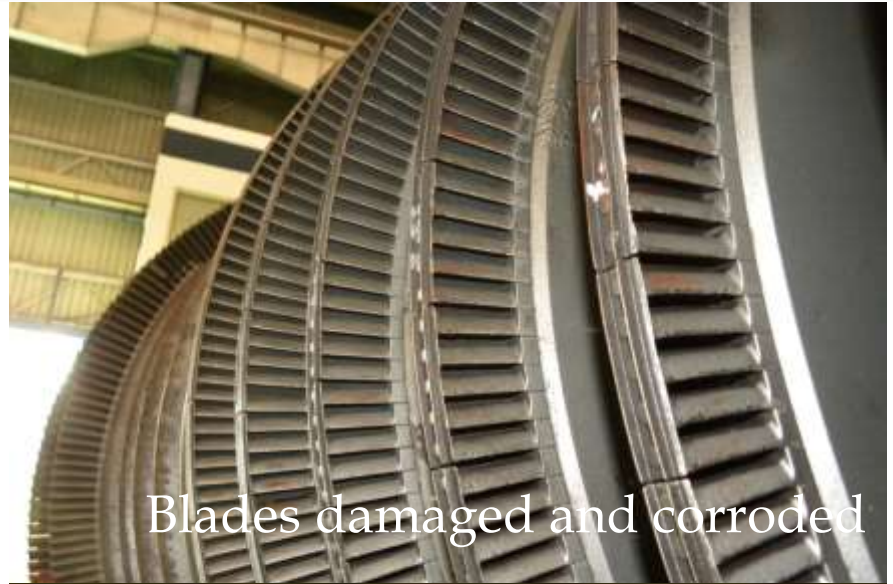
Blades damaged and corroded

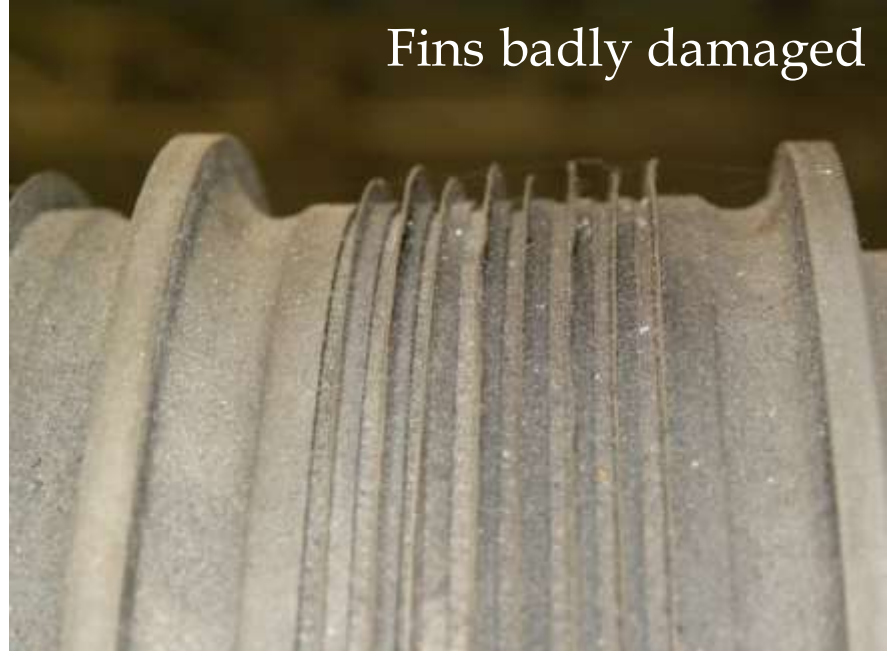
Fins badly damaged

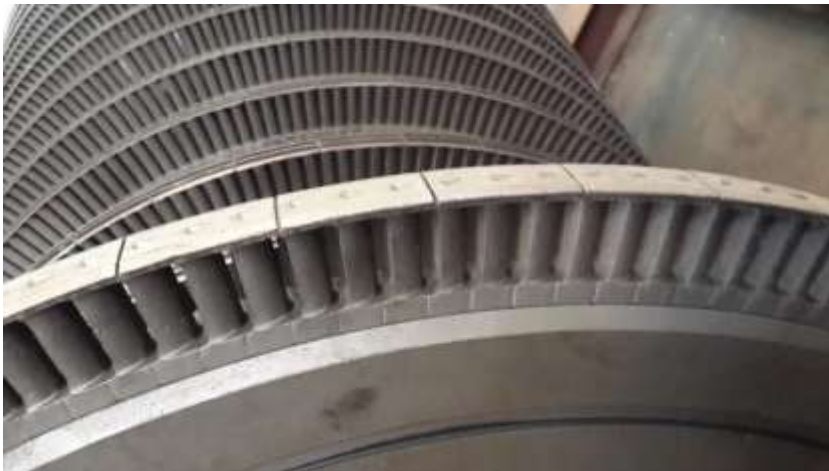
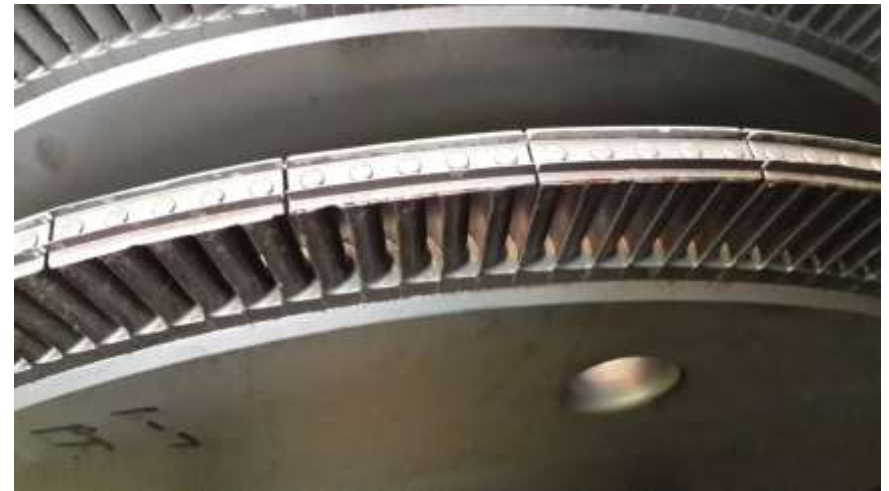
Damages to the rotor blades due to corrosion and age

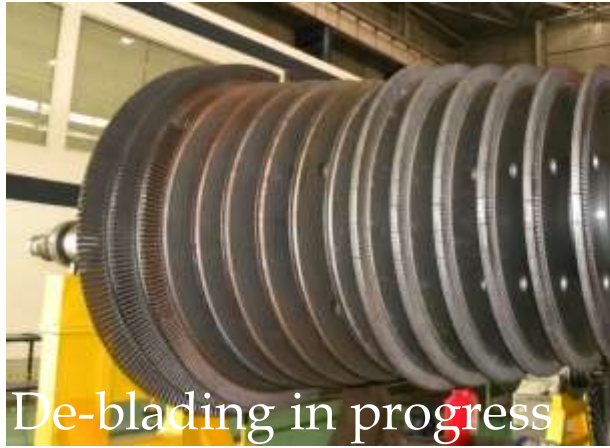
De-blading in progress

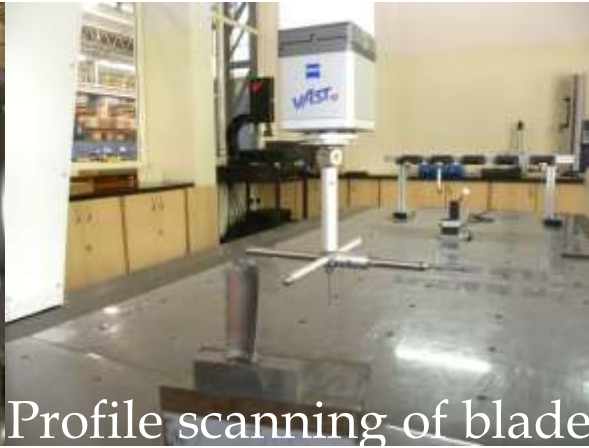
Profile scanning of blade

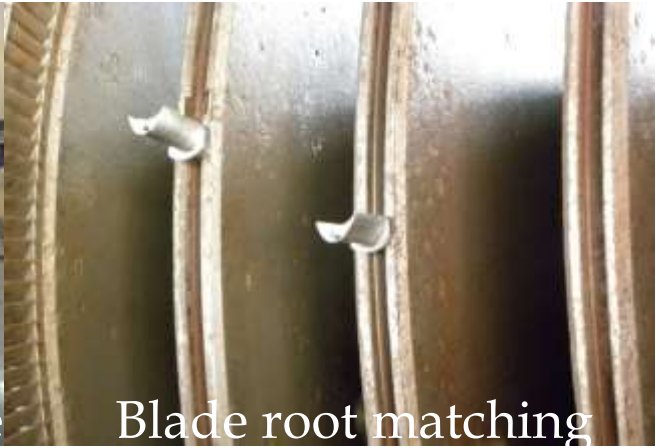
Blade root matching

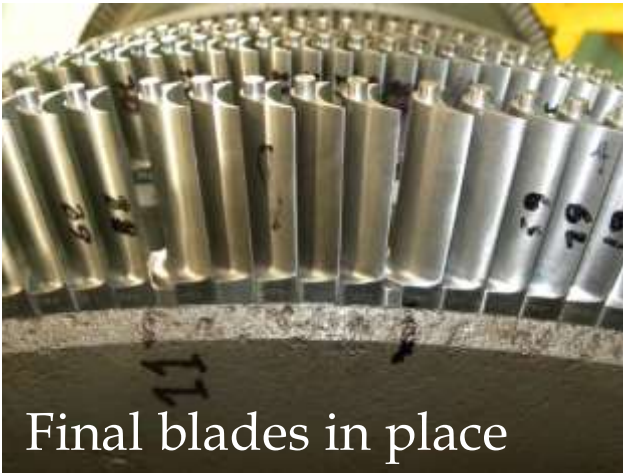
Final blades in place

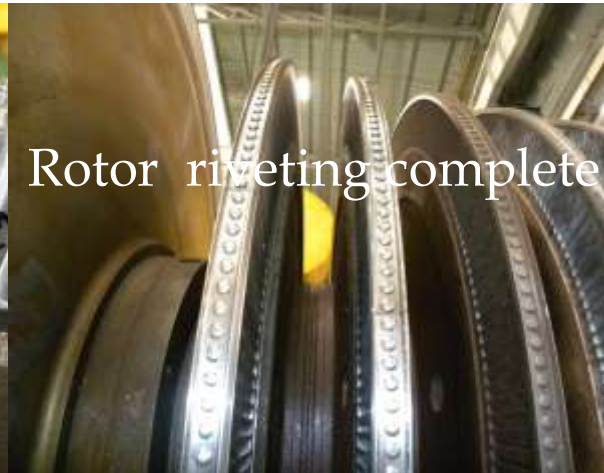
Rotor riveting complete

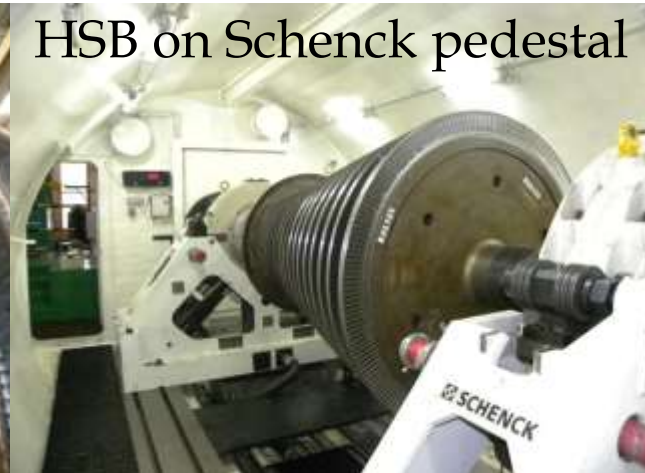
HSB on Schenck pedestal
