# Rotor Classified 'Beyond Economic Repair'

## INTRODUCTION

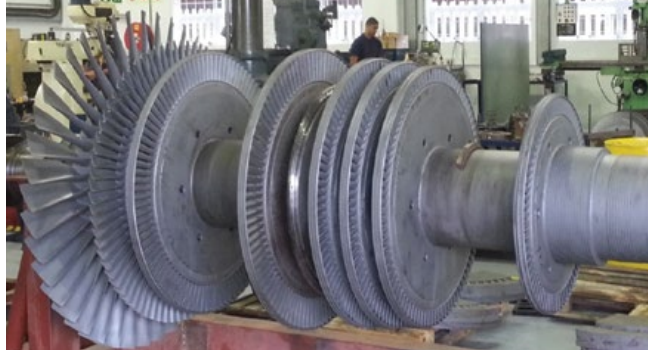
The customer is part of a large Sugar group in Southern Africa. The problem started with a close down in power generation due to break down of their 30 MW turbine at their unit. This turbine had been commissioned just 11 months back. The first information recorded was that the 30 MW was on full power and due to high vibration the turbine had tripped. The customer approached the OEM who reviewed the rotor and classified it as 'beyond economical repair'. The customer then decided to explore other options & service providers before taking the final decision and discovered Triveni Refurb team who reassured them that as an OEM ourselves we could support the customer in putting back their turbine to working condition.

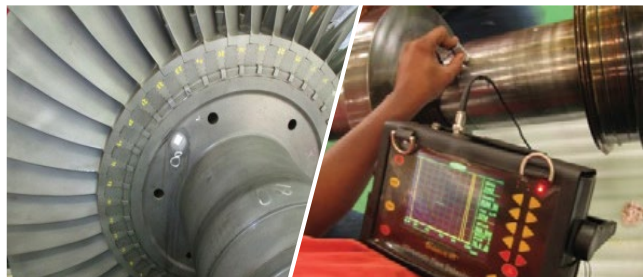
The visual inspection carried out at the customers place gave us adequate confidence that we could repair the rotor. We did RLA and NDT to establish the integrity and life of the rotor. The rotor was then shipped to India for further analysis.

The rotor was inspected, reverse engineered, necessary corrective actions taken, re-bladed, high speed balanced in the Schenck tunnel. All necessary tests were carried out as per the established procedures and we documented that the rotor was fit for use and the life of the rotor was also informed to the customer and then dispatched to the customer.
