Industry Case Study

Geothermal Power Plant

Enhancing 16MW Geothermal Turbine
Performance Client Overview

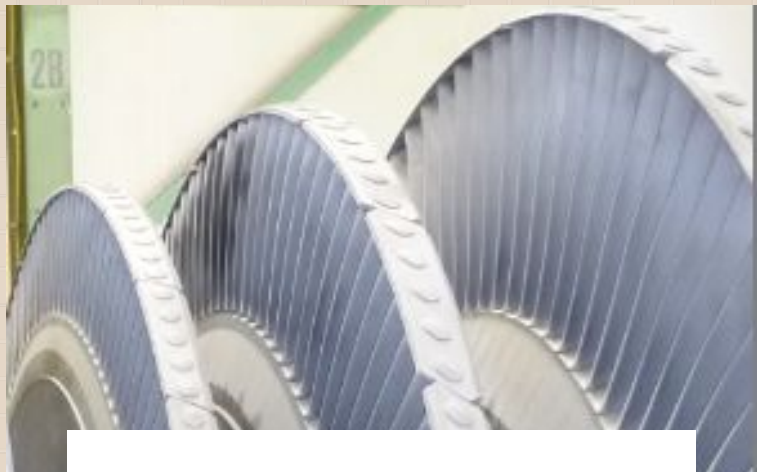
Old Rotor Design

Our client, a prominent player in the geothermal energy sector who was running a turbine of America's origin, was confronted with persistent challenges related to erosion and corrosion, and depleting the life of rotor material significantly hampering the performance of their 16MW geothermal turbine.

- (i) **Frequent Erosion in Blade Tenons:**
- (ii) **Cavity Formation in High-Pressure Gland Areas:**
- (iii) **Rotor Material Enhancement:**
