# Refurbishing Case Studies

**Modernise. Upgrade. Improve.**

Case Studies

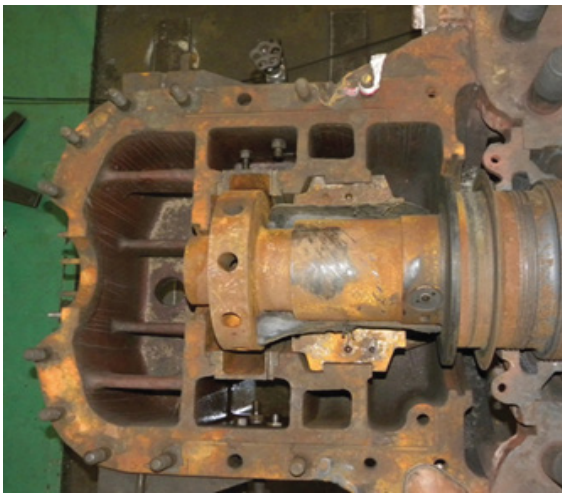
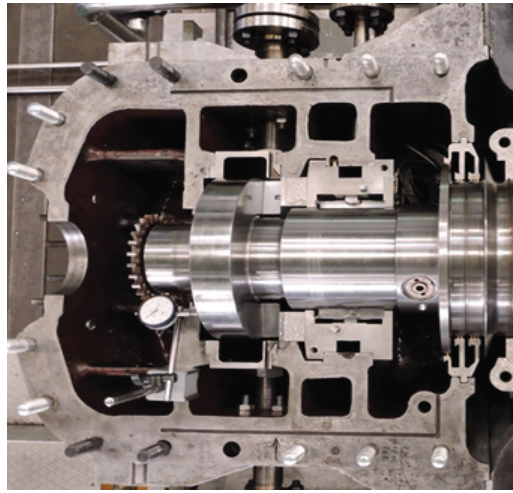
The challenge was to redesign the turbine internals within the casing boundary conditions. Convert an extraction condensing turbine to a single extraction back pressure turbine the job also needed additionally convert existing hydro-mechanical type to electro-hydraulic type (governor retrofit).

Triveni Refurbishing Redesigned the turbine to back pressure by reducing the number of stages and the exhaust pressure was changed from 0.1 ata to 5.0 ata. This turbine was successfully commissioned and is running well.

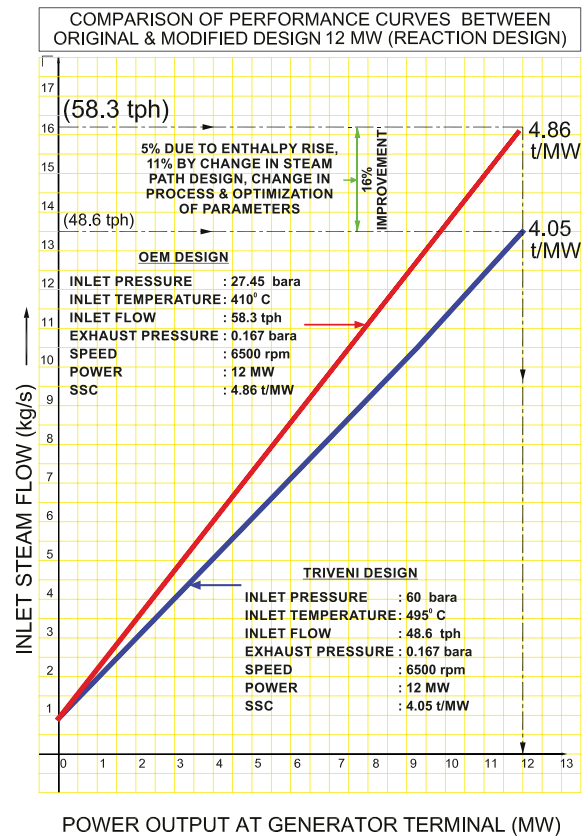
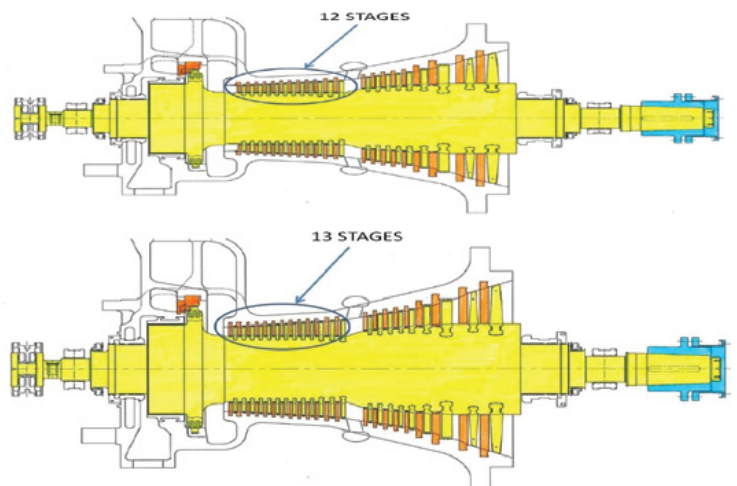
The challenge was to modify the turbine in the existing turbine boundary conditions of the casing by redesigning it for higher efficiency which convert the low inlet steam parameters to high inlet steam parameters.

Triveni Refurbishing redesigned the steam path within in the existing turbine boundary conditions of the casing. The efficiency of the turbine **improved by 16%** and the **payback period** was just **6 months**.

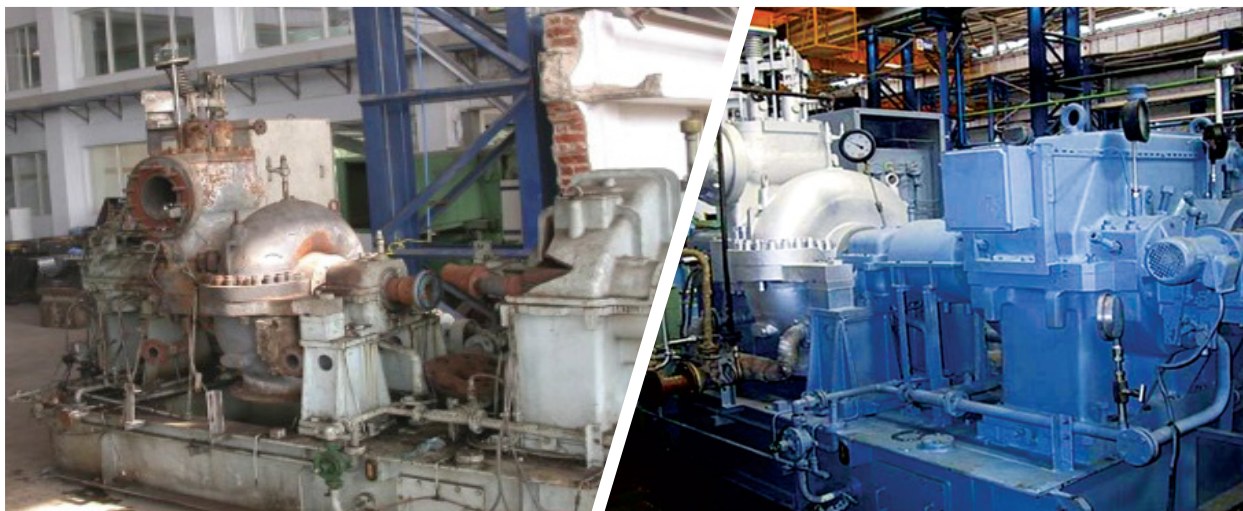
The customer is a reputed group in the **palm oil** segment from **Malaysia**. The turbine in operation was completely damaged and the rotor shaft was sheared off.

The challenge was to **rebuild** the complete turbine **without existing drawings** and replace the broken parts ensuring that it operates at the **designed efficiencies**.

Triveni Turbines shipped the whole turbine to its factory in Bangalore where the Triveni Refurbishing team rebuilt the whole turbine through reverse engineering.

There was a need to manufacture new blades through reverse engineering and it was found that the old design (root blades) was no longer useable.

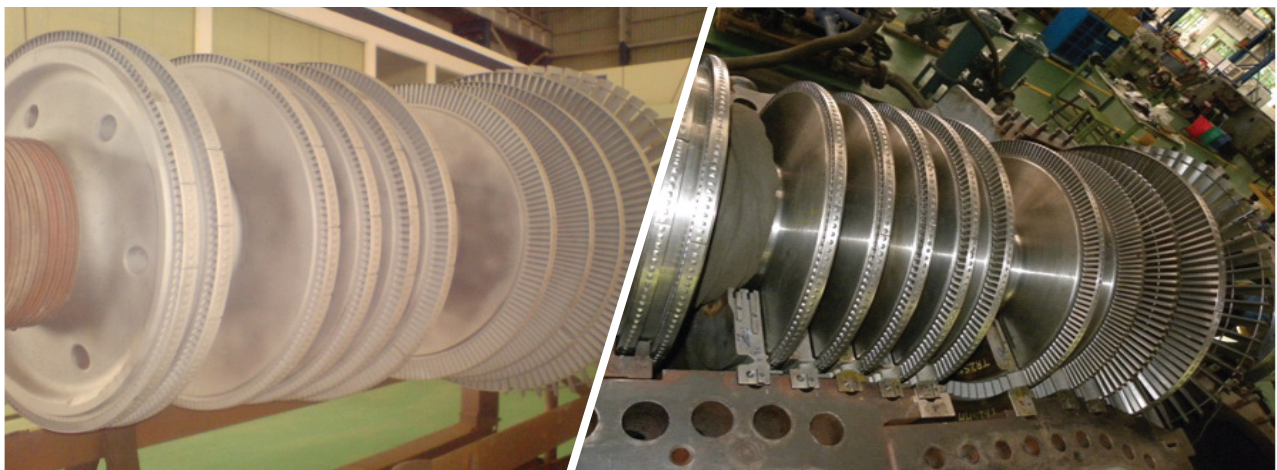
Triveni Turbines took up the challenge and decided to map the existing steam path and interpose on it the new Triveni Turbines design to review if it will work. The new design was a feasible option and would require a full steam path change including introduction of a new row of blades and a new diaphragm.

Based on this a **10 stage** rotor was redesigned to a **11 stage** rotor.

We needed to manufacture new blades and found that the old design of root was no longer used and a decision was taken after consulting the customer to replace the same with our new design.

The rotor was rebuilt and assembled in the turbine. The turbine is on full power for over 2 years with no issues since.

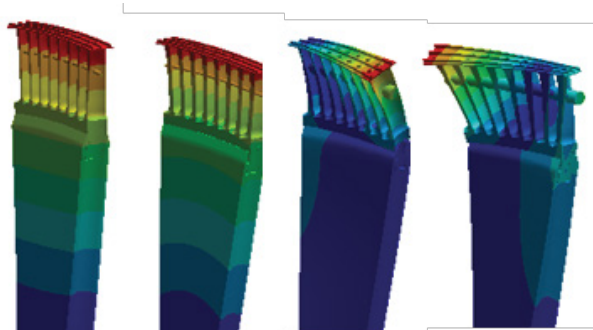
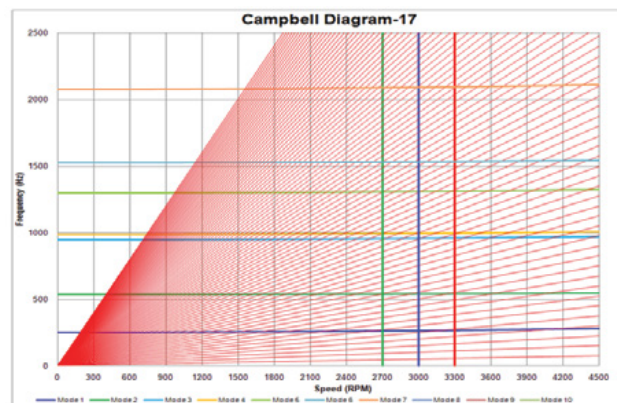
Campbell diagram

Existing blade root, profile and nozzles design were analysed individually and together. This is done by analysing LCF, HCF and other analysis as required using the latest software. This enables us to decide the necessary improvements in design to be made whether on root, profile or nozzles to achieve the operating parameters and boundary conditions without undue stresses.

In one Example - Post analysis we decided to include lacing wire as a damping arrangement

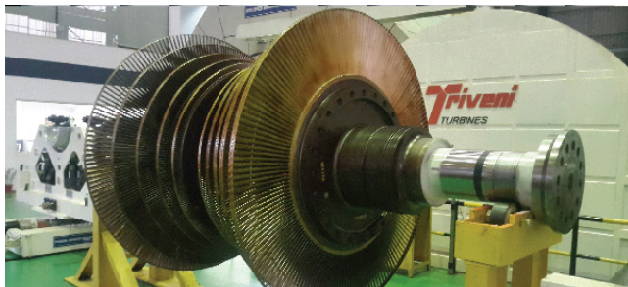
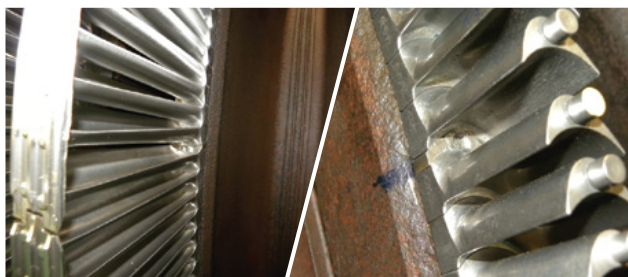
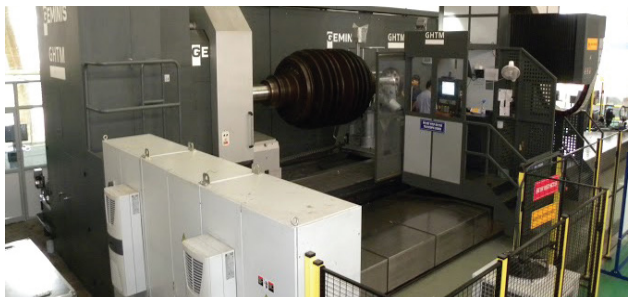
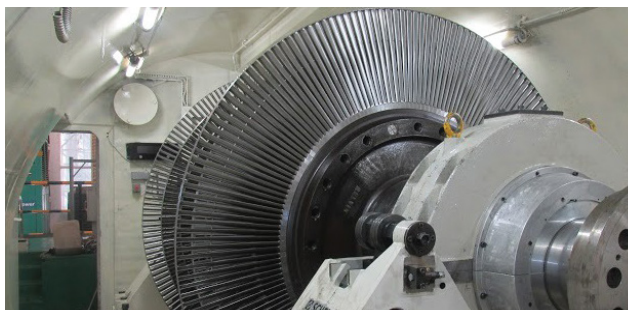
The customer is an IPP from Southern Africa, generating over **500 MW** of power. It was operating a Turbine Generator Set which was commissioned in **1956**. Post overhauling, a new rotor was replaced in the Turbine. The blades of one row of this rotor broke within 2 weeks of operation. This also led to vibration and damage to the adjacent rows.

The blade design was studied in detail to identify the reasons for the breakage and subsequently necessary design changes were made to ensure that the same does not recur.

The rotor has now been put into operation and is operating trouble free.

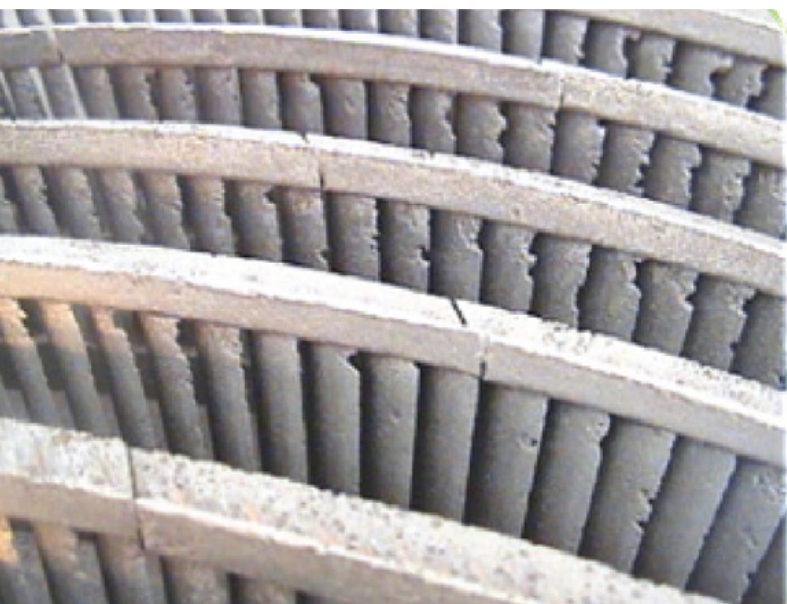
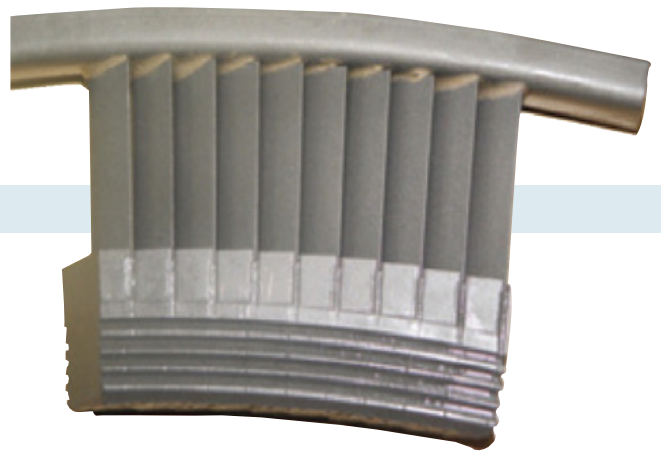
The challenge was to recreate the blade profiles and the blade packets. 10 blades made one packet and every 3rd blade had a profile angle change which had to be incorporated. Further, the original packet was brazed with gold and silver which was an expensive option to recreate.

Triveni Turbines took up the challenge and created a new methodology to **weld the blade** packets together and all necessary tests and validations were done to rule out the future possibilities of problems during operations the turbine was put back to operation successfully.

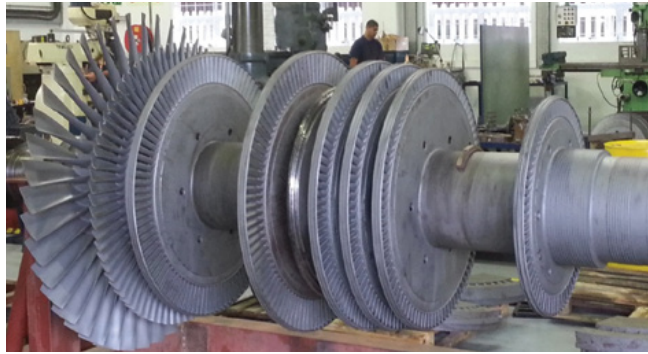
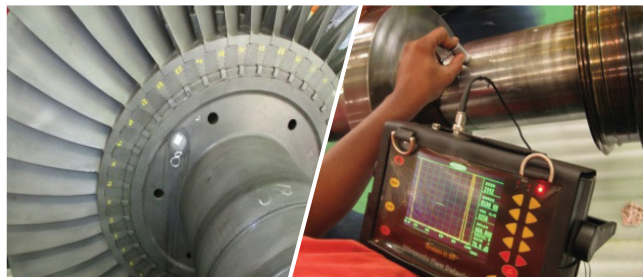
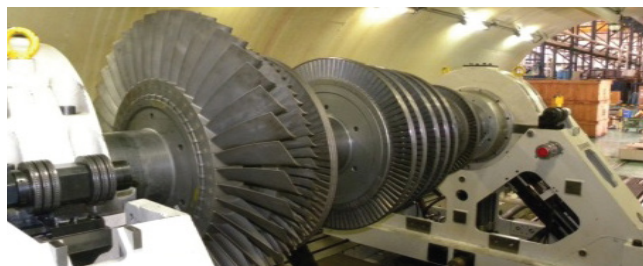
The customer is part of a large Sugar group in Southern Africa. The problem started with a close down in power generation due to break down of their 30 MW turbine at their unit. This turbine had been commissioned just 11 months back. The first information recorded was that the 30 MW was on full power and due to high vibration the turbine had tripped. The customer approached the OEM who reviewed the rotor and classified it as 'beyond economical repair'. The customer then decided to explore other options & service providers before taking the final decision and discovered Triveni Refurb team who reassured them that as an OEM ourselves we could support the customer in putting back their turbine to working condition.

The visual inspection carried out at the customers place gave us adequate confidence that we could repair the rotor. We did RLA and NDT to establish the integrity and life of the rotor. The rotor was then shipped to India for further analysis.

The rotor was inspected, reverse engineered, necessary corrective actions taken, re-bladed, high speed balanced in the Schenck tunnel. All necessary tests were carried out as per the established procedures and we documented that the rotor was fit for use and the life of the rotor was also informed to the customer and then dispatched to the customer.

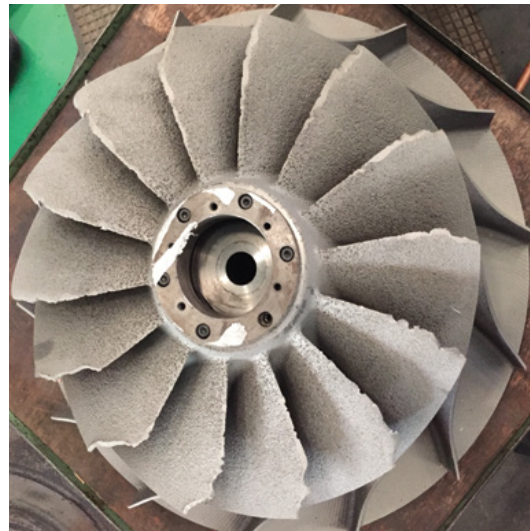
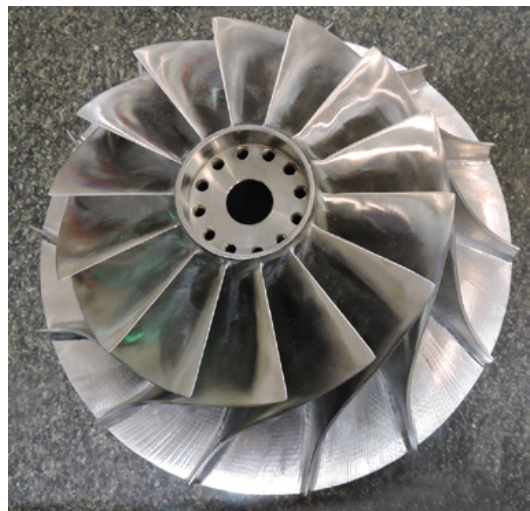
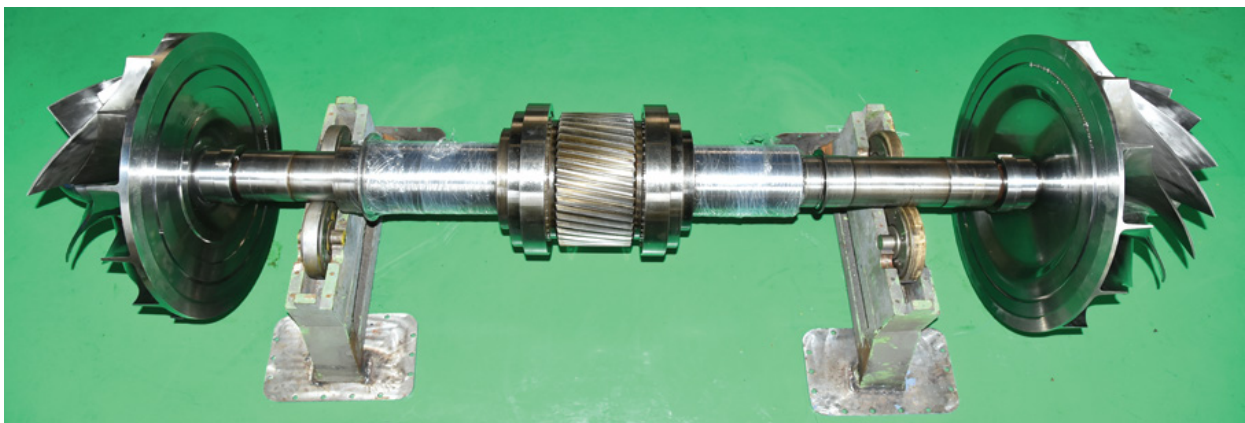
The customer is a reputed **Steel group** in the **Middle East**. The compressor impeller was damaged during the operation and required replacement.

Triveni Turbine deputed design expert along with **3D scanner** at site to complete the reverse engineering **in 2 days**. The equivalent material of impeller was identified and TTL took proactive action for ordering the raw material forgings.

New impeller along with pinion shaft was manufactured & also **High speed balanced** in Vacuum balancing tunnel within **6 months**.

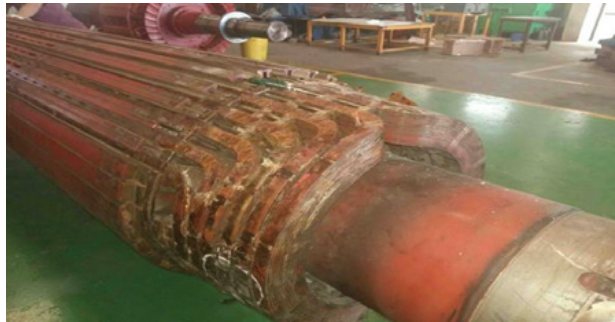
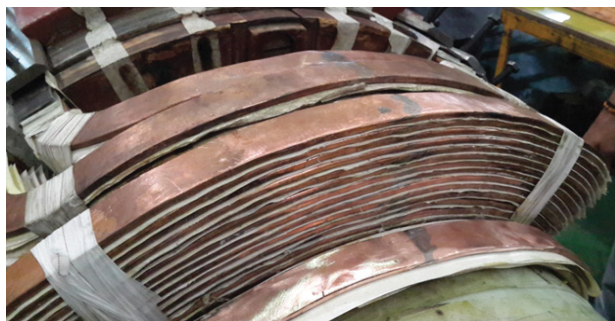
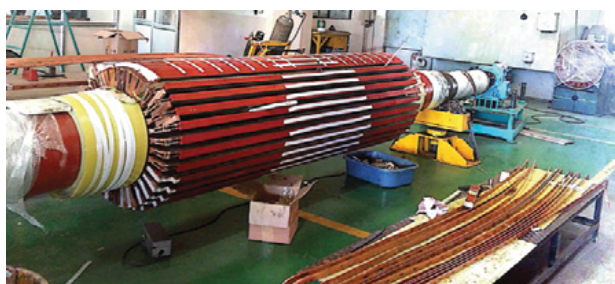
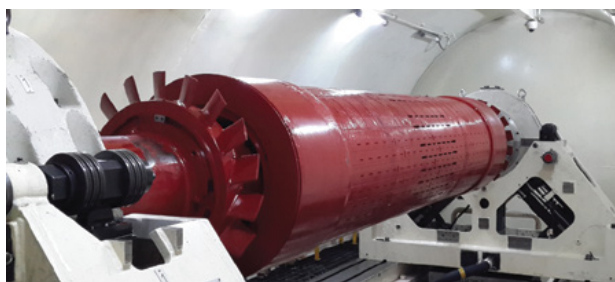
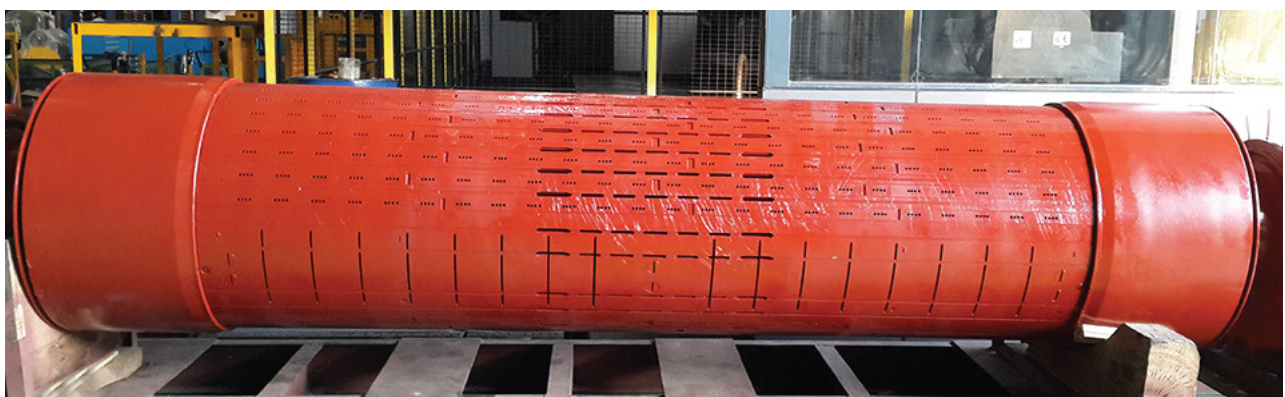
Client is a leading **paper & pulp industry**. Their **35 MW** generator rotor experienced heavy vibration during excitation and hence, were unable to load the generator.

On inspection, the root cause of the issue was improper brazing of rotor windings. This was leading to contact between winding & end rings during rotation and hence, created faults in rotor and distortion on the magnetic flux resulting **vibration** while exciting the **alternator**

Removing of rotor coils / windings & replacement of faulty windings. Complete **re-insulation**, static tests, before & after **high speed dynamic balancing** in Vacuum tunnel. Rotor has been commissioned and running successfully since May 2016. A series of tests were done in this process which included

- Resistance test,
- High frequency test @ 400HZ,
- Impedance test for the Rotor
- The IR test,
- Resistance test & surge comparison test for the armature
- RSO test was also conducted for the alternator.

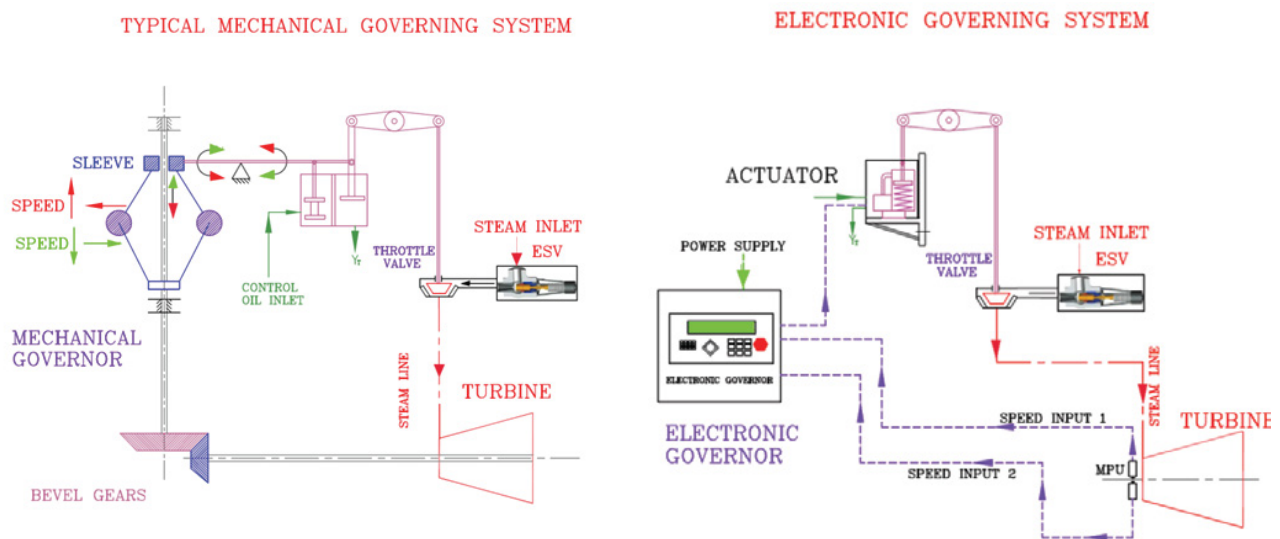
There are a large number of legacy and older equipment operating with mechanical governing systems which become sluggish over a period of time and require to be adjusted at regular intervals to avoid risk to the turbine.

Triveni refurbishing has a dedicated team that works with customer to convert existing mechanical systems to electronic governing system whether simple non configurable or the high end configurable systems which do away with the need of a standalone PLC depending on customer requirement

Review the existing architecture and build the new one to support the system, implement and commission the project. Triveni Refurb team has implemented a number of such systems across the world
