# Refurbishing Case Studies

Case Studies

**Any** age  
make  
turbine

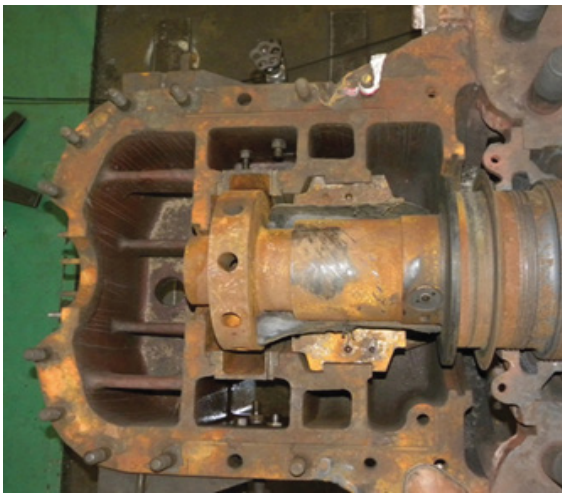
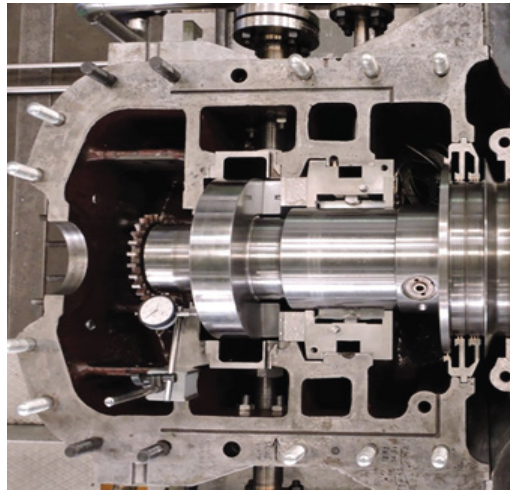
The challenge was to redesign the turbine internals within the casing boundary conditions. Convert an extraction condensing turbine to a single extraction back pressure turbine the job also needed additionally convert existing hydro-mechanical type to electro-hydraulic type (governor retrofit).

Triveni Refurbishing Redesigned the turbine to back pressure by reducing the number of stages and the exhaust pressure was changed from 0.1 ata to 5.0 ata. This turbine was successfully commissioned and is running well.

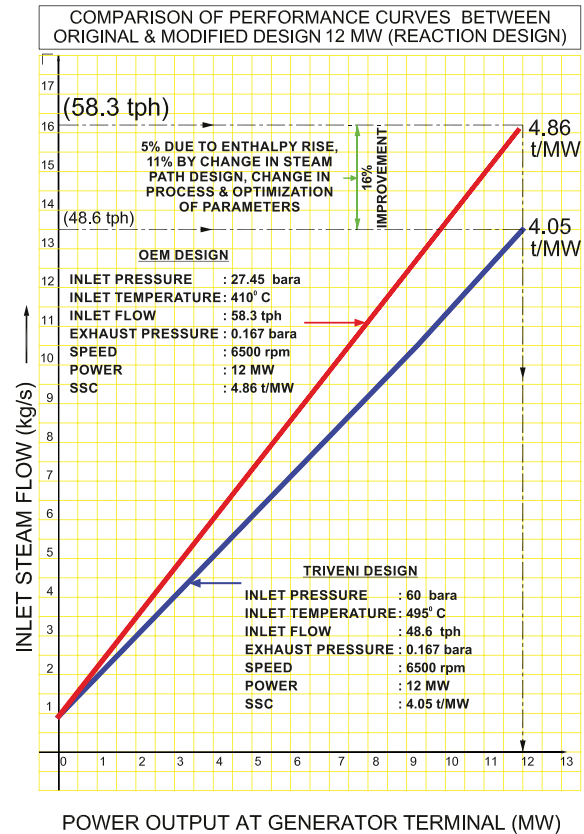
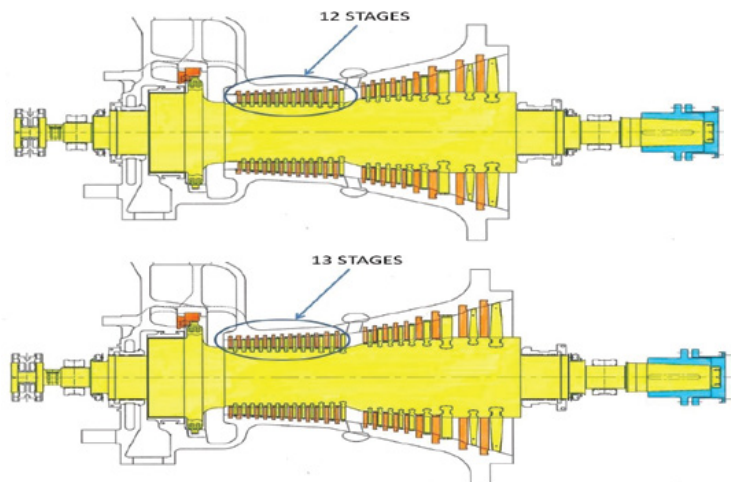
Parameter	Unit	Without extraction		With extraction	
		Original design	Modified design	Original design	Modified design
Inlet steam pressure	bar (a)	27.45	60	27.45	60
Inlet steam temperature	°C	410	495	410	495
Inlet enthalpy	kJ/kg	3259.5	3410.4	3259.5	3410.4
Exhaust pressure (vacuum)	bar(a)	0.17	0.17	0.17	0.17
Inlet Steam Flow	tph	58.8	49.2	68.4	57.6
Extraction steam pressure (Uncontrolled)	bar (a)	....	....	6.8	6
Extraction steam flow	tph	0	0	20	13
Exhaust steam flow	tph	58.8	49.2	48.4	44.6
Speed	rpm	6500	6500	6500	6500
Power	MW	12	12	12	12
Specific Steam Consumption	t/MW	<b>4.9</b>	<b>4.1</b>	<b>5.7</b>	<b>4.8</b>
No. of stages		1+21	1+22	1+21	1+22

Triveni Refurbishing redesigned the steam path within in the existing turbine boundary conditions of the casing. The efficiency of the turbine **improved by 16%** and the **payback period** was just **6 months**.

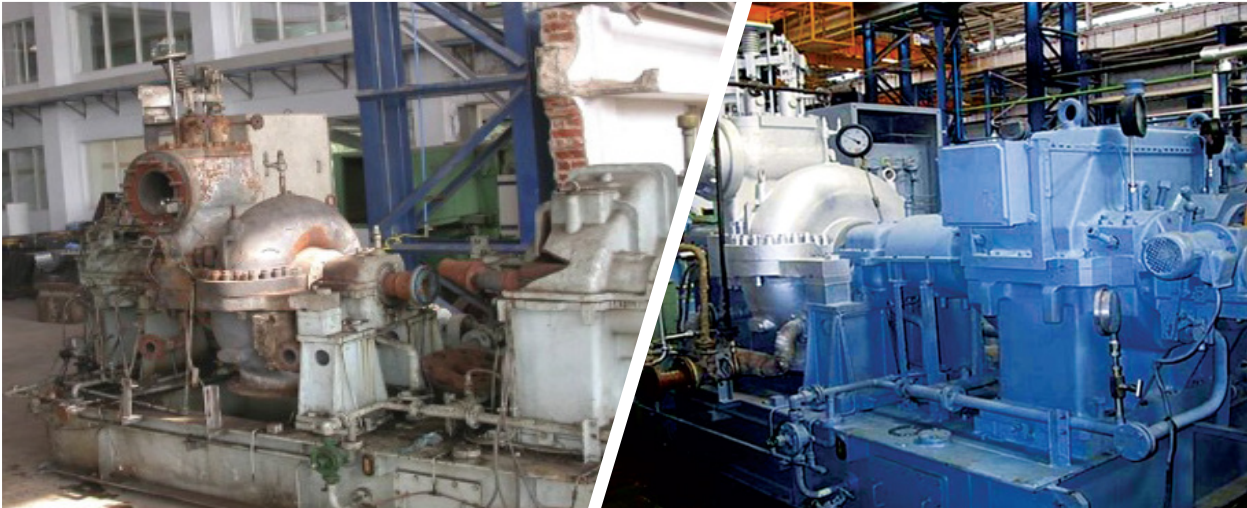
The customer is a reputed group in the **palm oil** segment from **Malaysia**. The turbine in operation was completely damaged and the rotor shaft was sheared off.

Triveni Turbines shipped the whole turbine to its factory in Bangalore where the Triveni Refurbishing team rebuilt the whole turbine through reverse engineering.

There was a need to manufacture new blades through reverse engineering and it was found that the old design (root blades) was no longer useable.

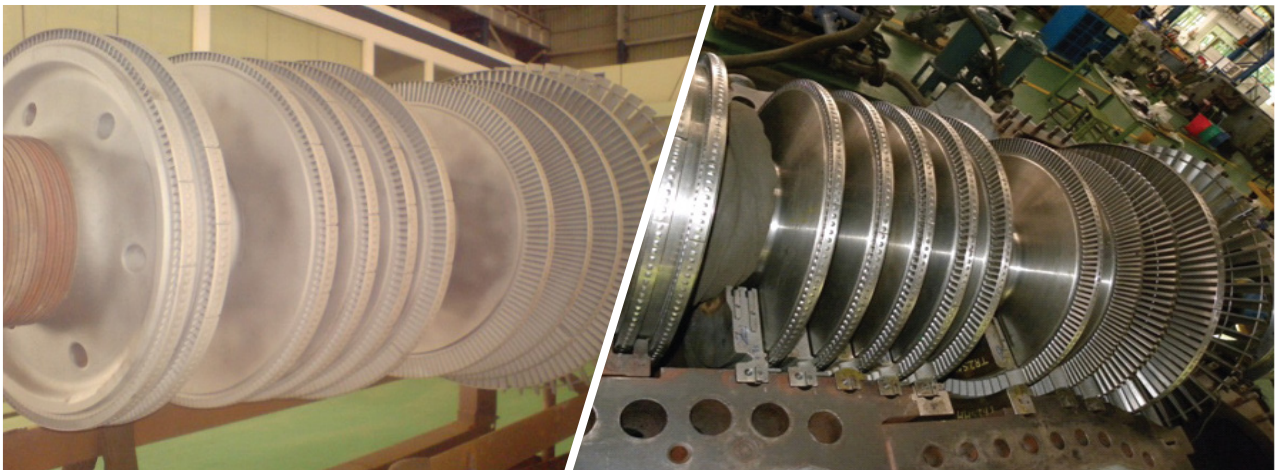
Based on this a **10 stage** rotor was redesigned to a **11 stage** rotor.

We needed to manufacture new blades and found that the old design of root was no longer used and a decision was taken after consulting the customer to replace the same with our new design.

The rotor was rebuilt and assembled in the turbine. The turbine is on full power for over 2 years with no issues since.

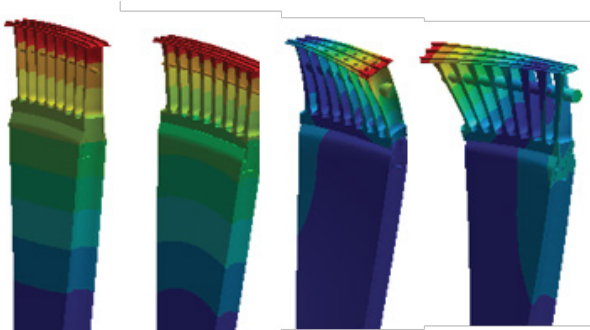
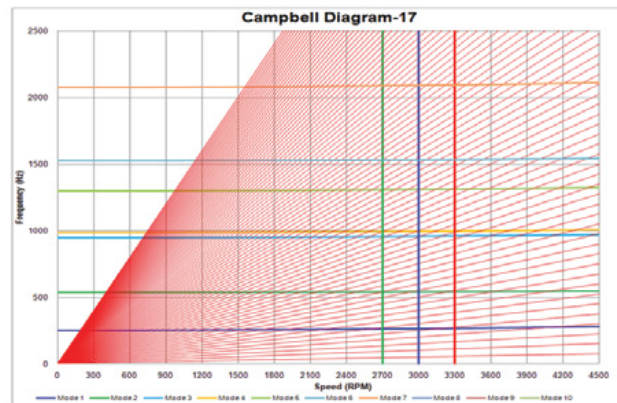
Campbell diagram

In one Example - Post analysis we decided to include lacing wire as a damping arrangement

Existing blade root, profile and nozzles design were analysed individually and together. This is done by analysing LCF, HCF and other analysis as required using the latest software. This enables us to decide the necessary improvements in design to be made whether on root, profile or nozzles to achieve the operating parameters and boundary conditions without undue stresses

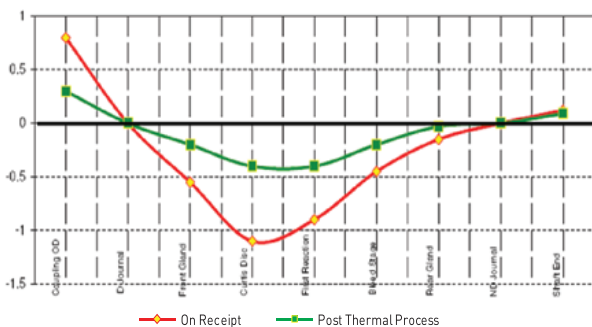
On receipt of the turbine and inspection of run out we found that the turbine had been subjected to a **complex bend** of **1.8 mm** across the length of the shaft and the challenge was to use the same shaft as per instructions of the customer.

On review of the possible solutions the best way forward to remove the complex bend was to de-blade the rotor and subject it to a **thermal cycle** to remove all the stresses and enable us to **bring** the rotor within the desired levels of tolerances of straightness. The thermal cycle is shown below and we achieved the desired results.

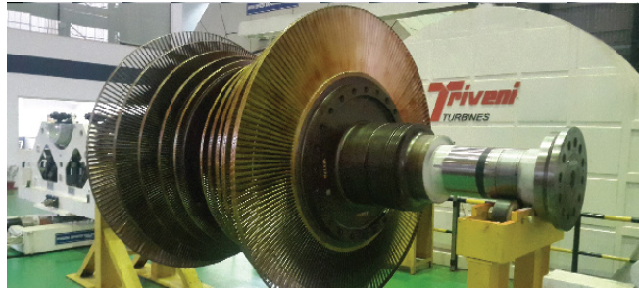
The customer is an IPP from Southern Africa, generating over **500 MW** of power. It was operating a Turbine Generator Set which was commissioned in **1956**. Post overhauling, a new rotor was replaced in the Turbine. The blades of one row of this rotor broke within 2 weeks of operation. This also led to vibration and damage to the adjacent rows.

The blade design was studied in detail to identify the reasons for the breakage and subsequently necessary design changes were made to ensure that the same does not recur.

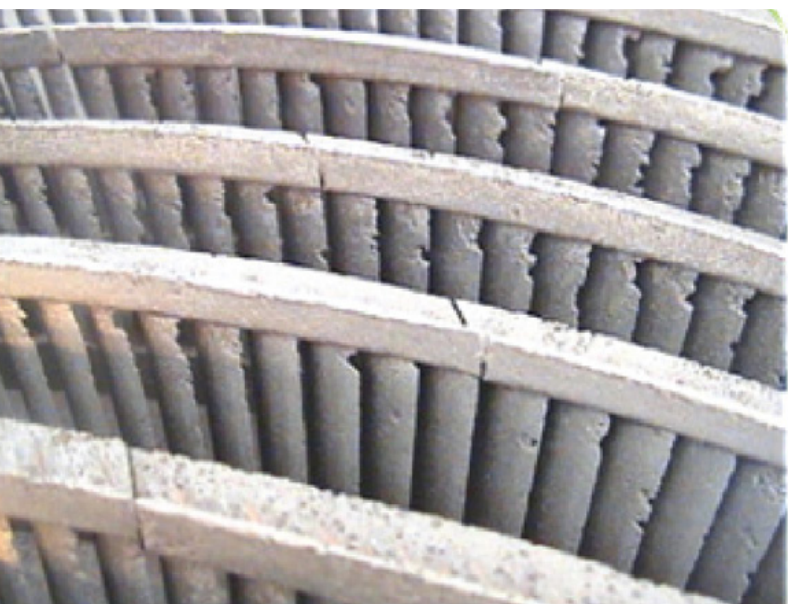
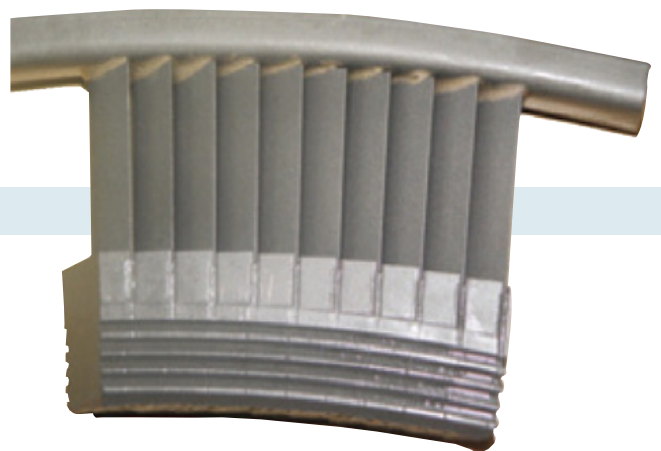
The challenge was to recreate the blade profiles and the blade packets. 10 blades made one packet and every 3rd blade had a profile angle change which had to be incorporated. Further, the original packet was brazed with gold and silver which was an expensive option to recreate.

Triveni Turbines took up the challenge and created a new methodology to **weld the blade** packets together and all necessary tests and validations were done to rule out the future possibilities of problems during operations the turbine was put back to operation successfully.

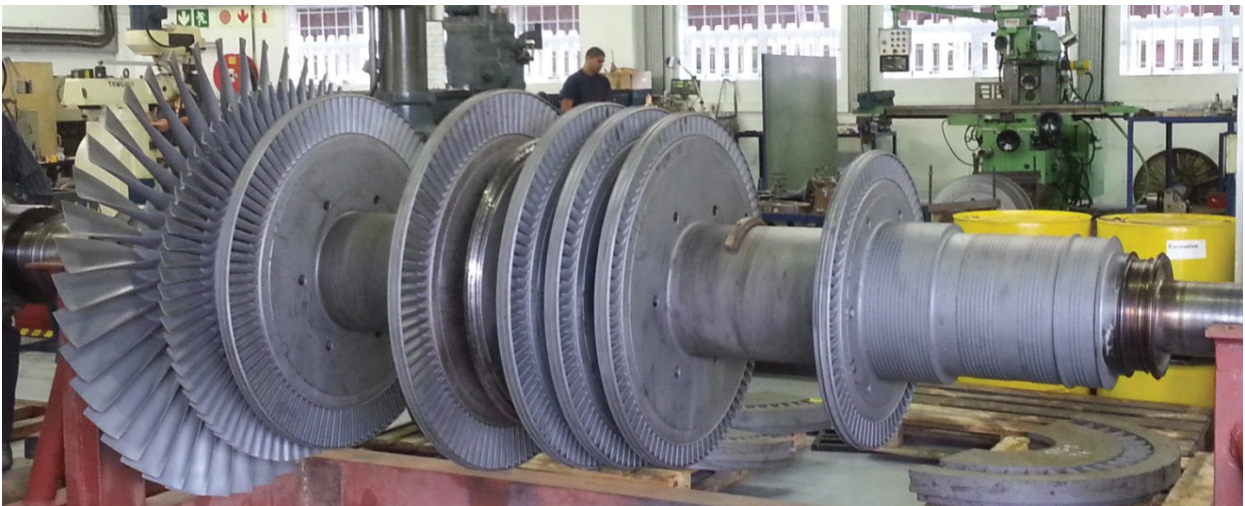
The customer is part of a large **Sugar group** in **Southern Africa**. The problem started with a close down in power generation due to break down of their 30 MW turbine at their unit. This turbine had been **commissioned just 11 months back**. The first information recorded was that the 30 MW was on full power and due to high vibration the turbine had tripped. The customer approached the OEM who reviewed the rotor and classified it as **'beyond economical repair'**. The customer then decided to explore other options & service providers before taking the final decision and discovered Triveni Refurbishing team. Our Team reassured them that as an OEM ourselves we could support the customer in putting back their turbine to working condition.

The visual inspection carried out at the customers place gave us adequate confidence that we could repair the rotor. The confidence was stemming out of the 4000 turbines we have commissioned across the world and knowing the fact that our turbines operate in more difficult conditions. To give the customer confidence in our statement we confirmed we would do the RLA and NDT and establish the integrity and life of the rotor. The rotor was then shipped to India for further analysis.

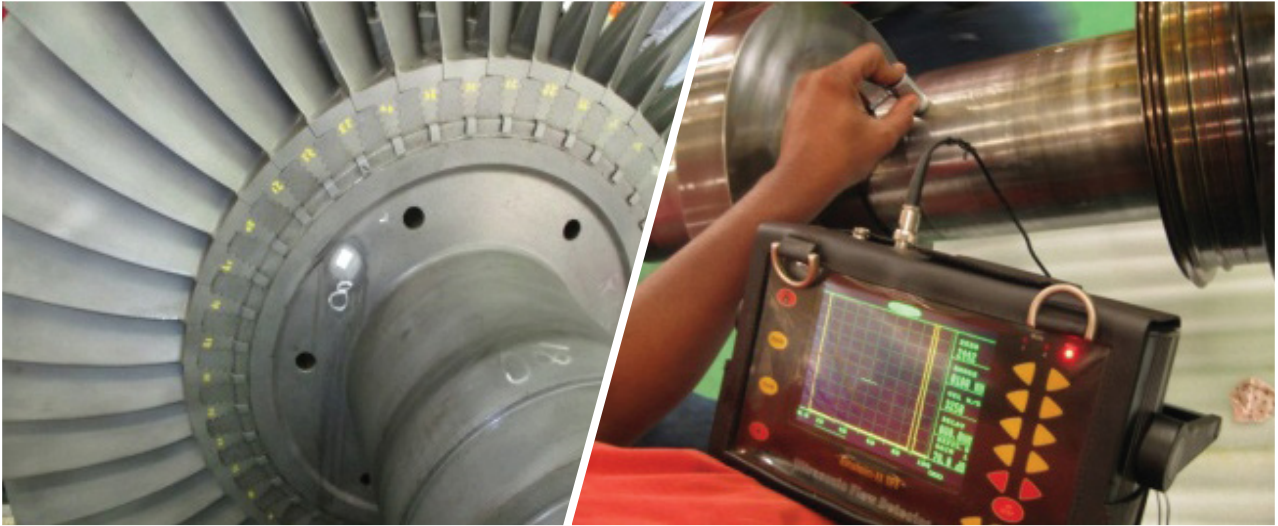
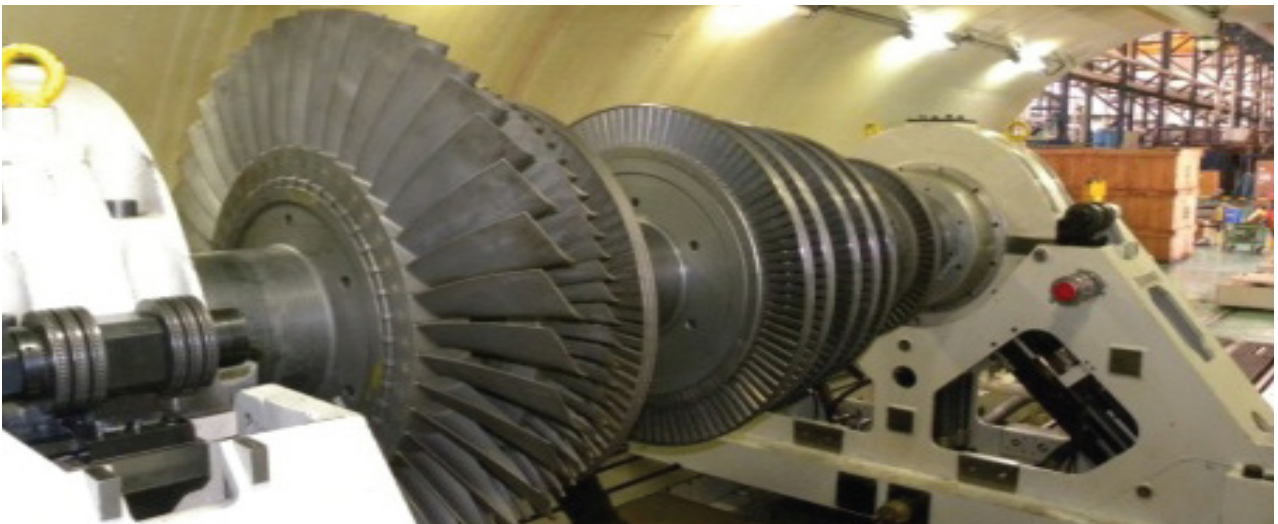
All necessary tests were carried out as per the established procedures and we documented that the rotor was fit for use and the life of the rotor was also informed to the customer.

The rotor was then inspected, reverse engineered, necessary corrective actions taken, re-bladed, high speed balanced in the Schenck tunnel and then dispatched to the customer.

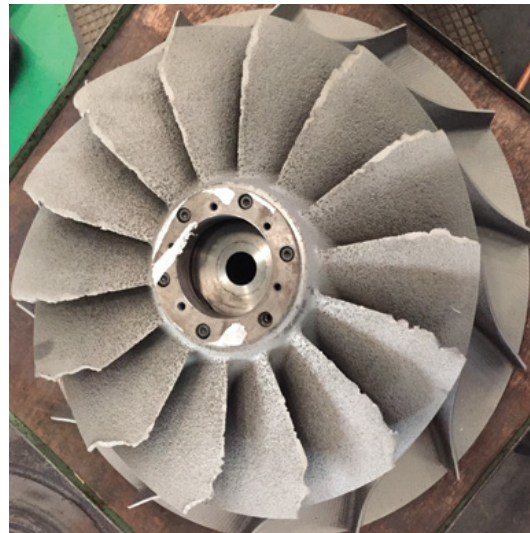
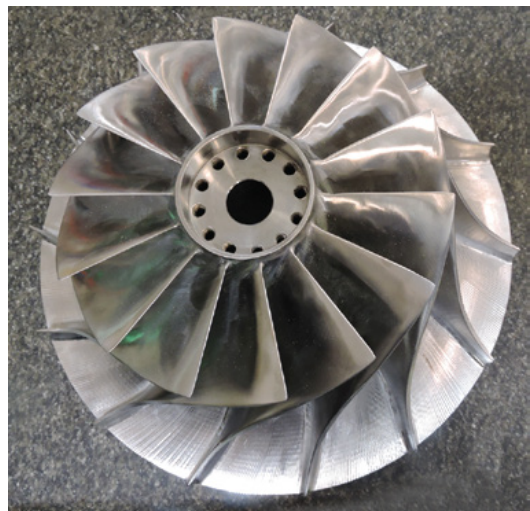
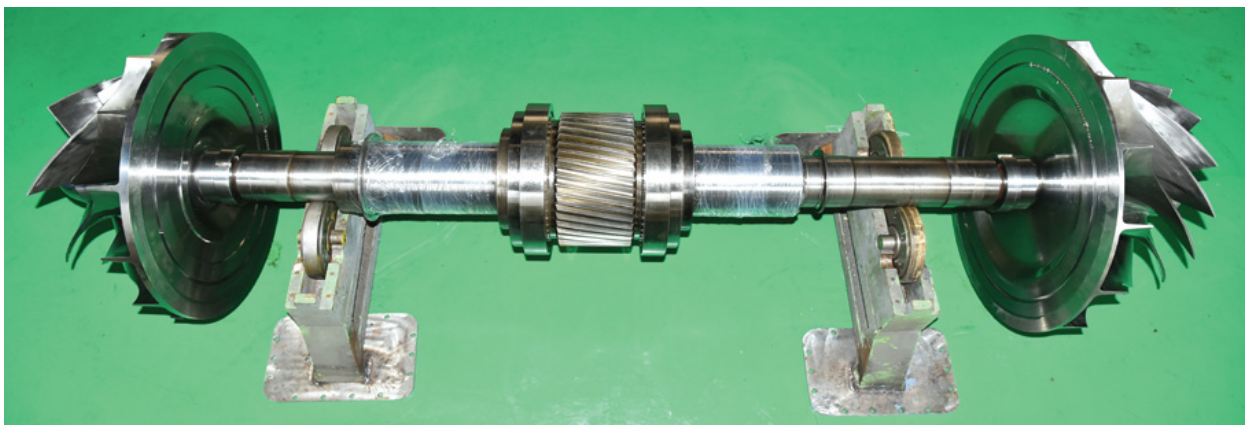
The customer is a reputed **Steel group** in the **Middle East**. The compressor impeller was damaged during the operation and required replacement.

Triveni Turbine deputed design expert along with **3D scanner** at site to complete the reverse engineering **in 2 days**. The equivalent material of impeller was identified and TTL took proactive action for ordering the raw material forgings.

New impeller along with pinion shaft was manufactured & also **High speed balanced** in Vacuum balancing tunnel within **6 months**.

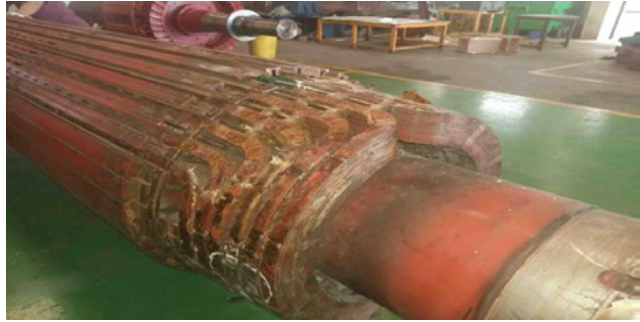
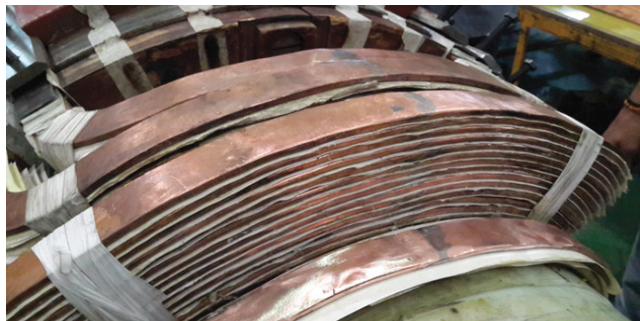
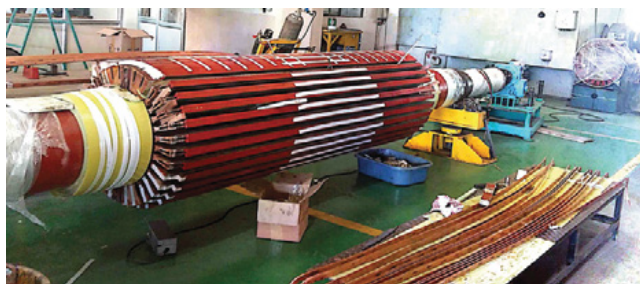
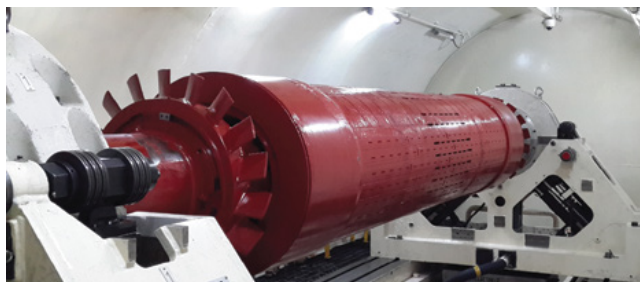
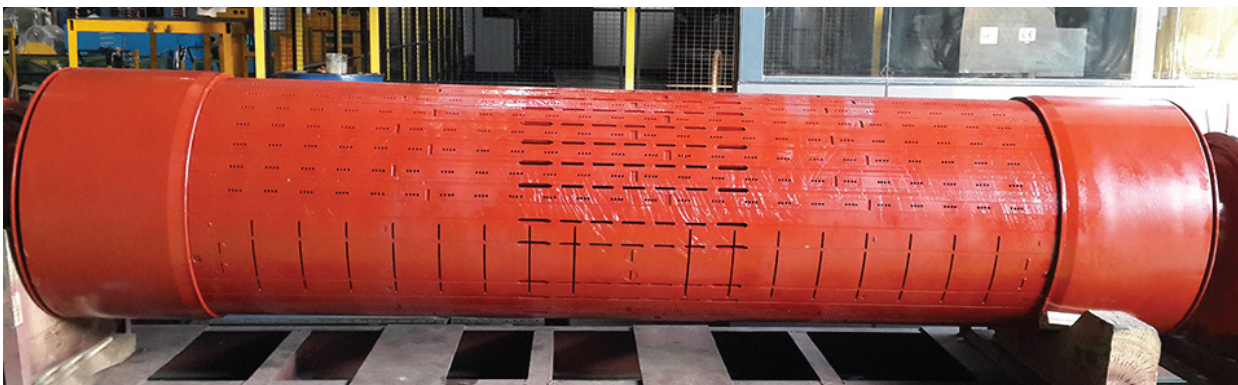
On inspection, the root cause of the issue was improper brazing of rotor windings. This was leading to contact between winding & end rings during rotation and hence, created faults in rotor and distortion on the magnetic flux resulting **vibration** while exciting the **alternator**

Removing of rotor coils / windings & replacement of faulty windings. Complete **re-insulation**, static tests, before & after **high speed dynamic balancing** in Vacuum tunnel. Rotor has been commissioned and running successfully since May 2016. A series of tests were done in this process which included

- Resistance test,
- High frequency test @ 400HZ,
- Impedance test for the Rotor
- The IR test,
- Resistance test & surge comparison test for the armature
- RSO test was also conducted for the alternator.

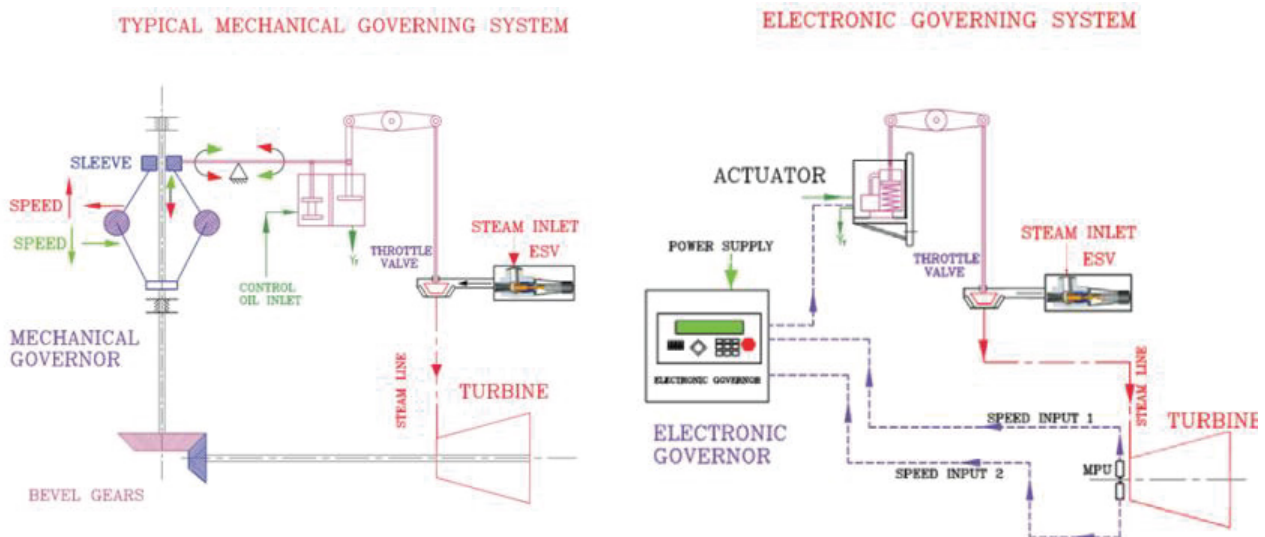
There are a large number of legacy and older equipment operating with mechanical governing systems which become sluggish over a period of time and require to be adjusted at regular intervals to avoid risk to the turbine.

Triveni refurbishing has a dedicated team that works with customer to convert existing mechanical systems to electronic governing system whether simple non configurable or the high end configurable systems which do away with the need of a standalone PLC depending on customer requirement
