Case Study
30 MW rotor repair

Status report

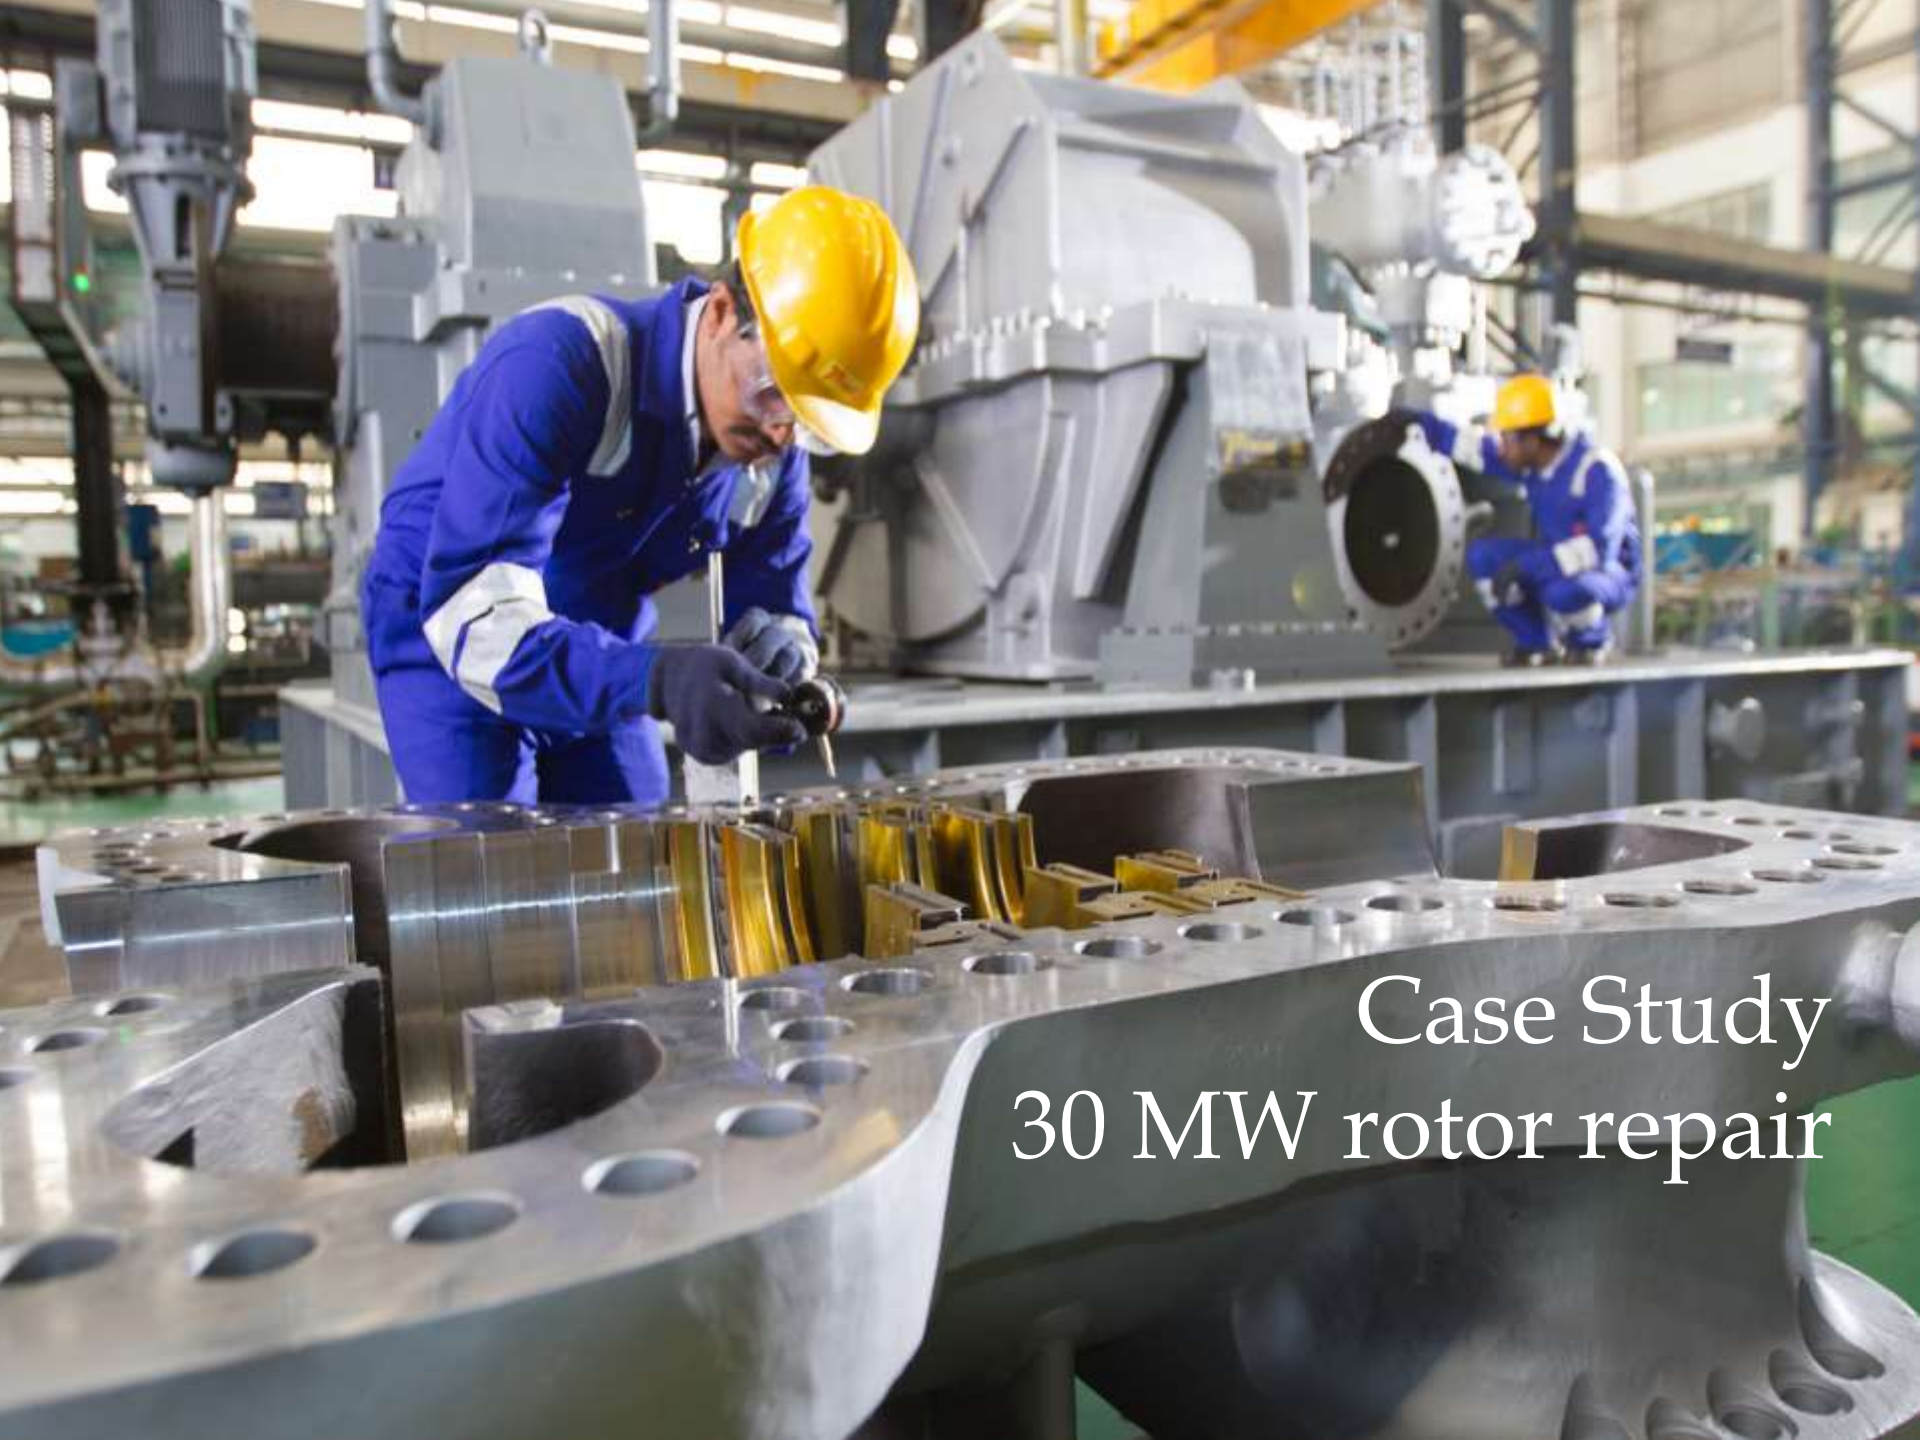
- After start up in the process of opening extraction a transient surge took place and the plant tripped.
- On opening, major damage to the rotor, found damaged and one blade in row 5 broken.
- Consulted number of companies none of whom were able to give a concrete recommendation

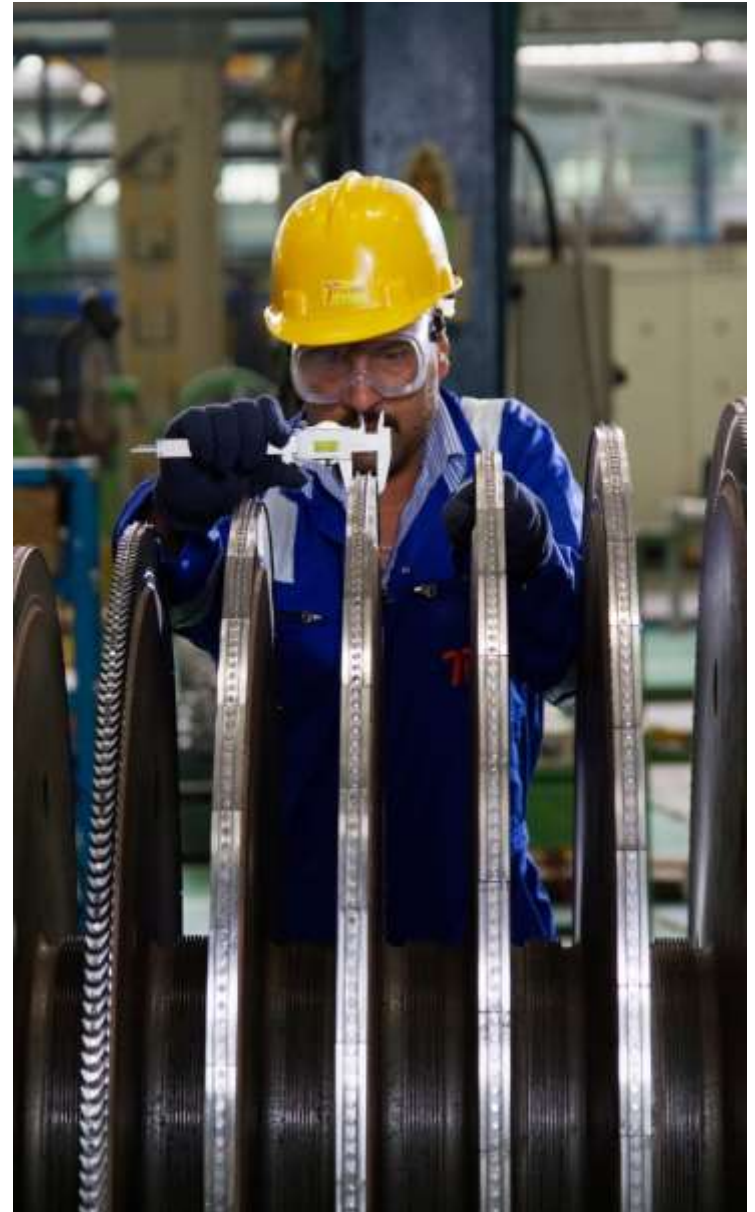
- There was no consistent report of the reason for failure.
- First interaction with customer at SASTA 2013
- *OEM refused to repair rotor, classified the same as 'beyond repair'*
- Customer had explored many repair options by then including number of OEM's
- Based on sequence of failure, confirmed same rotor will work riding on our confidence of handling over 2500 turbines worldwide
- Inspected the turbine at the supplier works in Durban and reinforced our position
- Invited customer to visit our works and review our capabilities which they did.
