Case Study
30 MW rotor bend removal and repair

30 Mw turbine rotor repair

30 MW SIEMENS HP ROTOR REPAIR A/C UGAR SUGARS (R-0745)

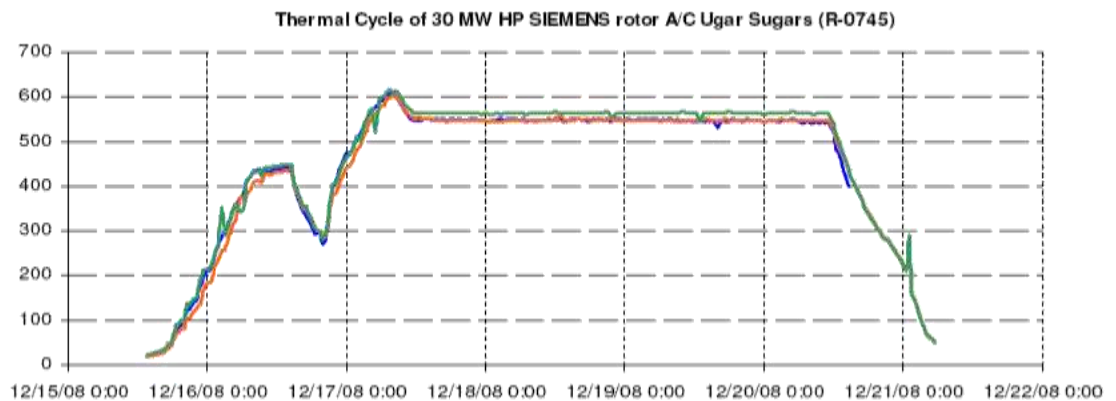
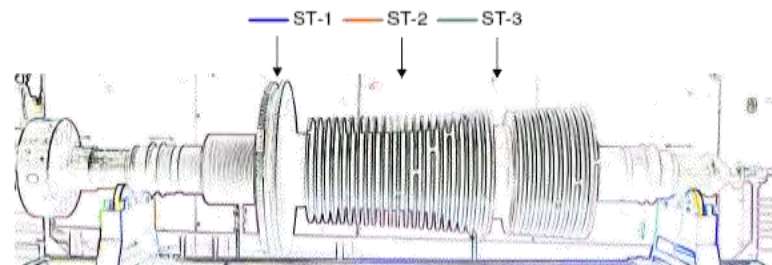
- Rotor removed and transported to Bangalore works and a run out check done
- Rotor Gland areas subjected to heavy rubbing & rotor seized *due to complex bend of 1.8 mm and blade breakages*

- Triveni reviewed all option and decided on the following solution
- Thermal cycle to ensure removal of stresses and bend and skin cut to ensure that run out is brought within 0.05 mm
- Changed the complete blade design to standardize with Triveni design
